The Inspection Company, LLC

Property Inspection Report

123 Any Street, Smyrna, GA 30080
Inspection prepared for: John Q. Customer
Real Estate Agent: Jane A. Agent - ABC Realty Company

Date of Inspection: 1/16/2015 Time: 9:00 AM
Age of Home: 12 years | Size: 3,455 SF estimated
Weather: 41°, sunny, recent rain

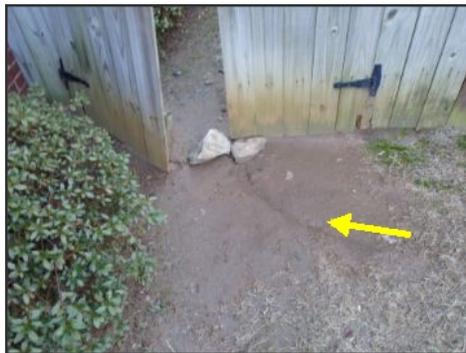
6.2. EXPOSED SOIL/MISSING GROUND COVER: There are areas on side D where there is exposed soil and erosion is occurring. It is advised to add vegetation/ground cover to correct the concern. Re-slope soil to gain adequate drainage. This is easily correctable. The Inspector advises the Client to arrange to have a professional landscape contractor further evaluate and address as necessary.

water pools--also lacking ground cover

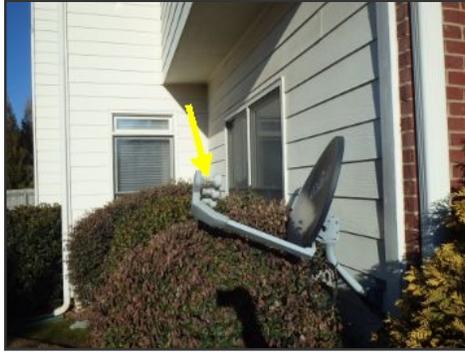
7.2. VEGETATION NEEDS MAINTENANCE: The shrubs and bushes are growing too close to the home (side C and side D), and they can cause moisture damage to the cladding and trim. The vegetation should be maintained to within 24" of the exterior of the building. The Inspector advises the Client to arrange to have a professional landscape contractor further evaluate and address as necessary.

overgrown shrubs--example

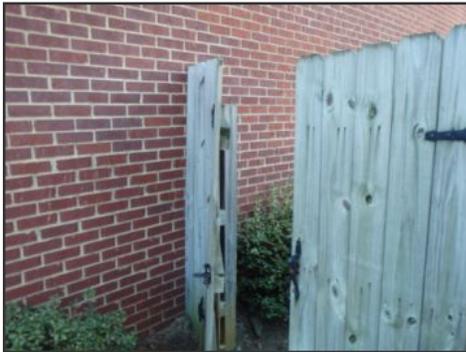
8.1. FENCE--GENERAL REPAIRS: The wood fence needs general repairs to address loose and misaligned boards. Some areas of rot were observed. The fence is nearing the end of its lifespan. The Inspector advises the Client to arrange to have a professional contractor further evaluate and address as necessary.

misaligned fence gate

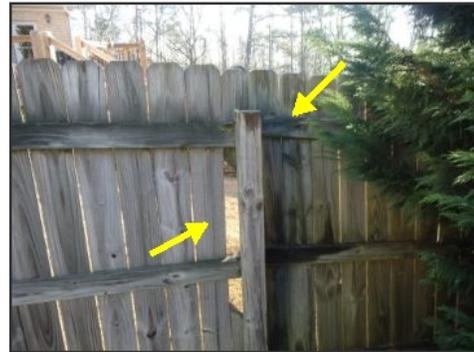
example damaged fence area

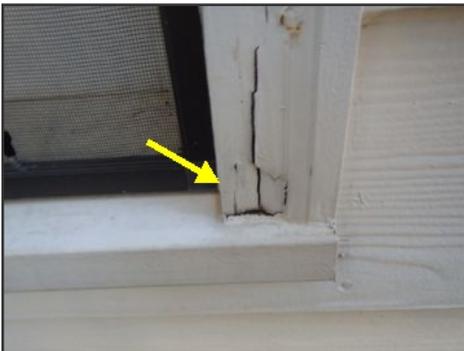
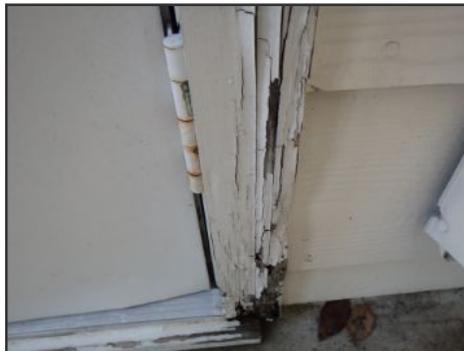
2.4. WOOD TRIM DETERIORATION--MINOR: The Inspector observed some minor areas of wood trim deterioration at side C. The areas of concern include corner boards at the chimney, window trim, and the trim around the doors. The damaged areas of trim should be replaced in-kind. The trim prevents water damage to the wall structure. The Inspector advises the Client to arrange to have a professional contractor further evaluate and address as necessary.

example deteriorated trim--side C

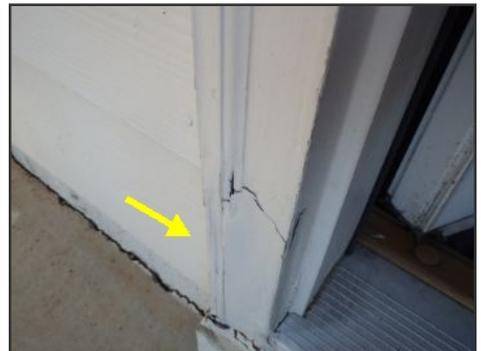
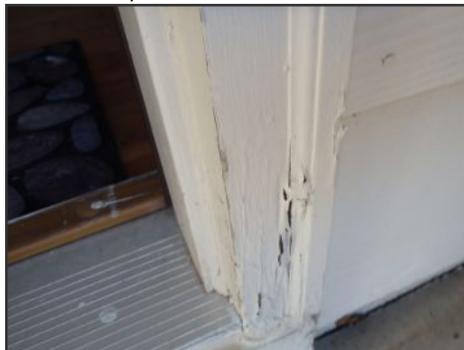
example damaged trim--side C at door

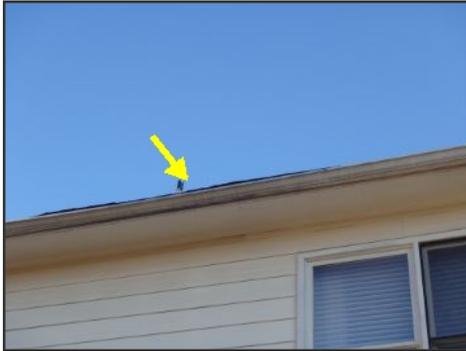
3.2. DETACHING GUTTERS: The Inspector observed that a section of gutter is detaching from the fascia at the side C. There is at least one leaking gutter joint at side A. See images. Failed gutters can cause water damage. The Inspector advises the Client to arrange to have a professional contractor further evaluate and address as necessary.

gutter is detaching at side C

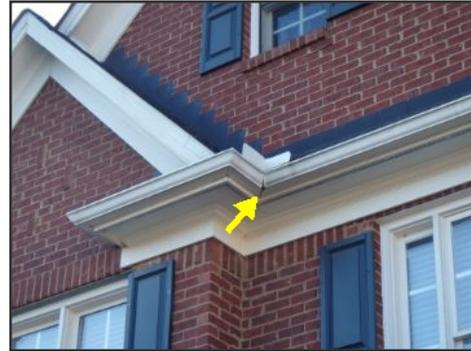
leaking gutter joint example

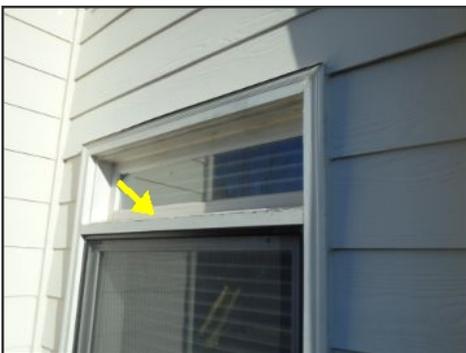
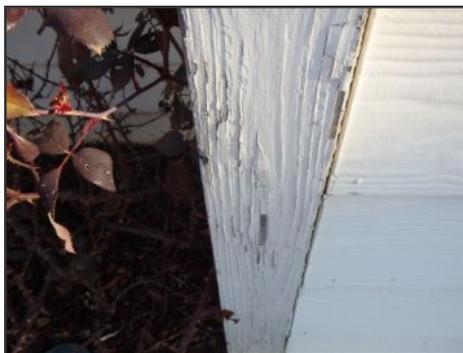
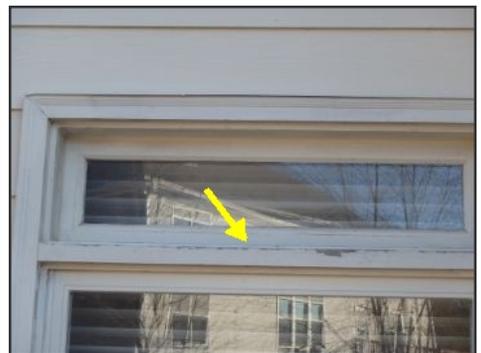
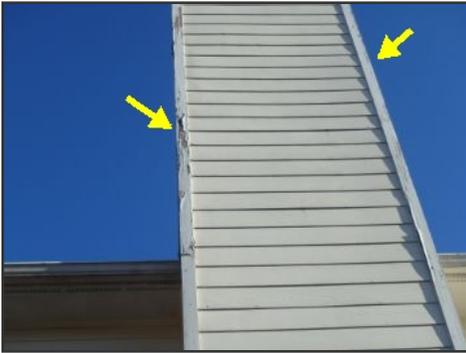
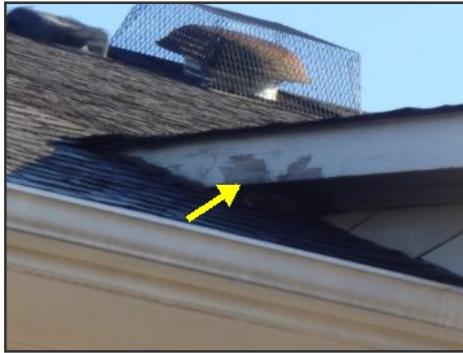
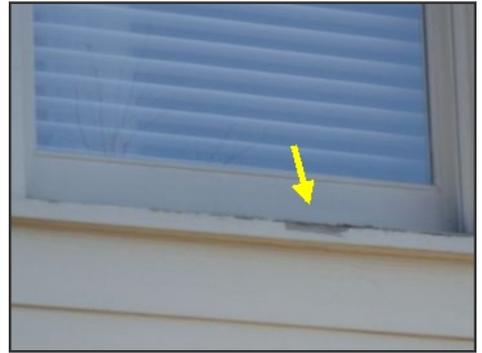
5.1. EXTERIOR PAINTING NEEDED--WOOD COMONENTS: The Inspector observed deteriorated exterior paint at the exterior of the home at the trim, eaves, and windows. It is important to maintain the exterior paint and caulk as to protect the wood from moisture deterioration. The Inspector advises the Client to arrange to have a professional painting contractor further evaluate and address as necessary.

example flaking paint

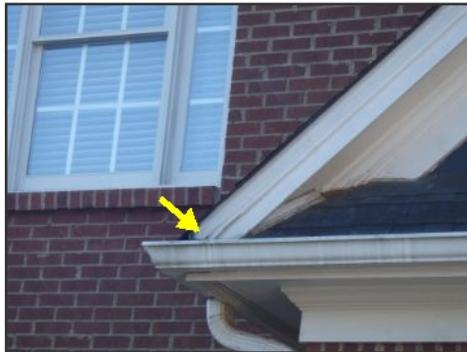
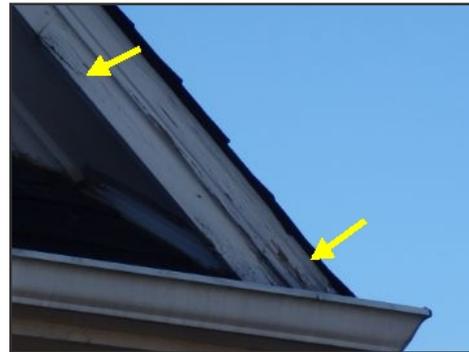
6.2. FASCIA DETERIORATION--LIMITED: The Inspector observed some minor areas of fascia deterioration at side A near the garage and at side C near the storage room. There may be hidden areas behind the gutters. The damaged areas of eaves should be repaired. The eaves prevent water damage to the wall structure. The Inspector advises the Client to arrange to have a professional contractor further evaluate and address as necessary.

minor fascia deterioration

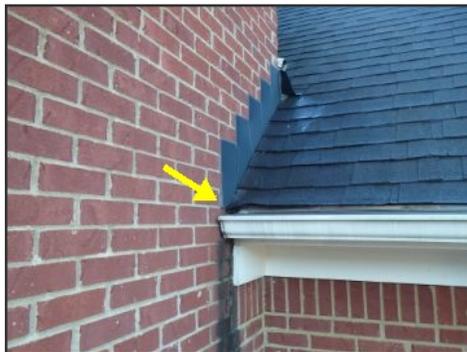
7.2. KICK-OUT FLASHING--MISSING: Kick-out flashing was not observed at the gutter-to-wall intersection at side A. This type of flashing helps divert water into gutters and away from the wall where it can cause damage. The Inspector advises the Client to arrange to have a professional contractor further evaluate and address as necessary.

missing kickout flashing

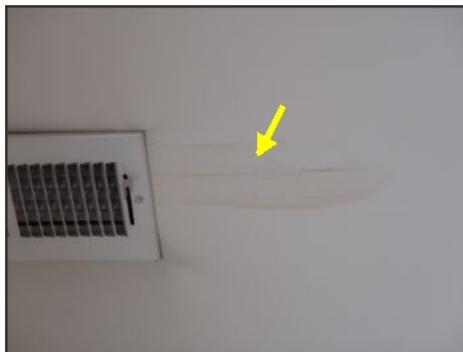
3.2. **MOISTURE STAINS--CEILING:** The Inspector observed moisture stains on the ceiling at the half bathroom. The stains appeared to be dry at the time of inspection as checked with a FLIR infrared camera. The concern is primarily cosmetic but the area should be monitored. Provide minor repairs as needed. The Inspector advises the Client to arrange to have a professional contractor further evaluate and address as necessary.

moisture stain--half bathroom

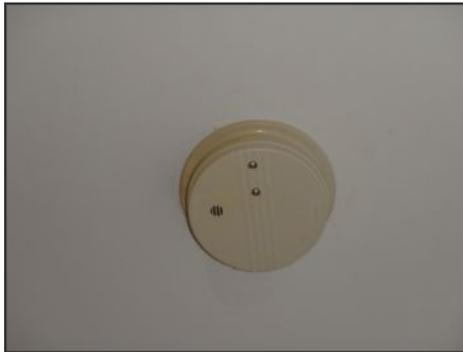
1.1. SMOKE DETECTORS SHOULD BE REPLACED DUE TO AGE: Replacement of existing smoke detectors is recommended due to estimated age exceeding 10 years. It is also highly recommended to add smoke detectors inside each bedroom. At least two hardwired and interconnected smoke detectors are highly recommended for every home, one for each level and one for each sleeping room too. It is very important to change smoke detector back-up batteries prior to occupancy and ongoing every six months. Purchase and install new detectors every ten (10) years as recommended by the US Fire Administration. Just like any electrical appliance, the components of smoke alarms wear out over time. When a smoke alarm reaches 10 years of use, the potential of failing to detect a fire increases substantially. Replacing them after 10 years reduces the likelihood of failure. Inoperable detectors can lead to serious injury or death should the home have a fire. The best recommended smoke detector type combines ionization and photoelectric technology into one unit. The smoke detectors should be mounted to within 12" of the ceilings. The Inspector also recommends the Client purchase at least two ABC rated fire extinguishers for the home.

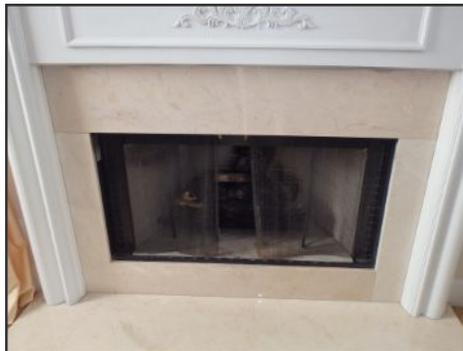
- 3.1. Appears normal for age.
- 3.2. CHARRED CERAMIC LOGS AT FIREPLACE: The Inspector observed that the fireplace has blackened gas logs. The cause could not be readily determined, but it is believed to have an incorrect type of burner. The Inspector advises the Client to arrange to have a professional chimney sweep further evaluate and address as necessary.
- 3.3. GAP AT GAS LINE ENTRANCE AT FIREBOX: The Inspector observed a gap at the gas line entrance to the firebox that has not been sealed. It should be sealed with heat-rated sealant. The Inspector advises the Client to arrange to have a professional contractor further evaluate and address as necessary.

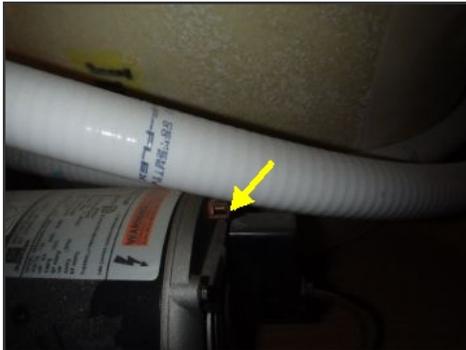
10.2. BONDING OF JETTED TUB MOTOR: The Inspector did not observe a bonding connection at the jetted tub motor. This is required when a home has grounded metal water pipes. The Inspector advises the Client to arrange to have a professional, licensed electrician further evaluate and address as necessary for safety.

no bonding connection

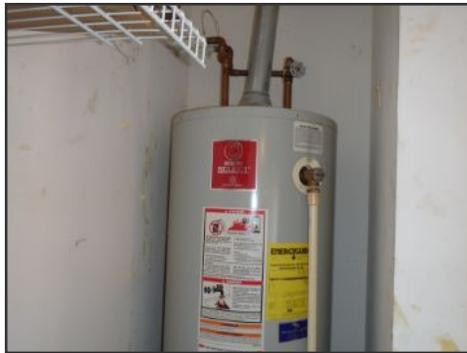
- 5.1. Appears normal. Appliance operated at time of inspection. Note that the wood stand has minor deflection--monitor as necessary.
- 5.2. EXCEEDED LIFESPAN: Though it operated at the time of inspection, it is noted that the water heater is well beyond the end of its useful lifespan and should be monitored for replacement. HUD estimates typical lifespans to be 10-11 years for tank water heaters. The Inspector advises the Client to arrange to have a professional, licensed plumber further evaluate and address as necessary.
- 5.3. **EXPANSION TANK:** The Inspector observed that the water heater does not have an **expansion tank** installed. **Expansion tanks** reduce stress on water heaters and water pipes associated from normal expansion of heated water. The Inspector advises the Client to arrange to have a professional plumbing contractor further evaluate and address as necessary.

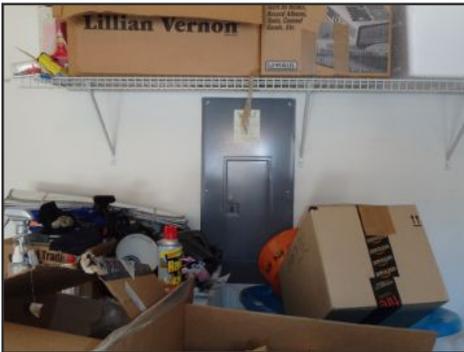
5.1. **OBSTRUCTED:** The electrical distribution panel was obstructed by home owner belongings at the time of inspection. The Inspector was unable to view inside panelboard. The Inspector advises the Client to arrange to have a professional, licensed electrician further evaluate if more information is desired.

panelboard--located at garage--obstructed from inspection

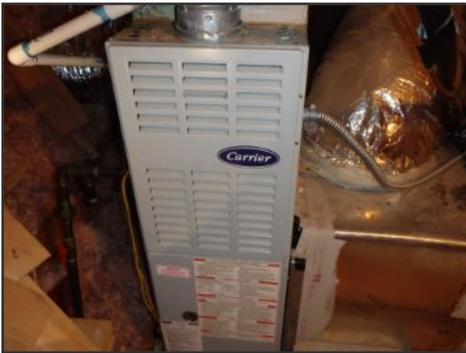
- 1.1. Appears normal. Heating system was operated during the inspection.
- 1.2. NEARING END OF LIFESPAN: It is noted that the furnace is nearing the end of its useful lifespan and should be monitored for replacement. HUD estimates typical lifespans to be 15-17 years for gas furnaces. Regular servicing is recommended. See service manual from manufacturer or contact NATE certified HVAC company. Aged furnaces can sometimes have hidden heat exchanger cracks that can be a carbon monoxide hazard.

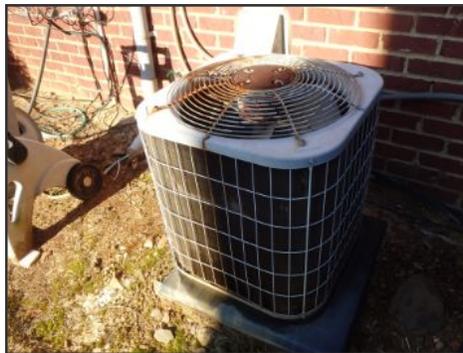
4.3. **NOT LEVEL--CONDENSER:** The condenser is not currently level. It should be made level so that internal parts stay properly lubricated. The Inspector advises the Client to arrange to have a licensed, NATE certified HVAC contractor further evaluate and address as necessary.

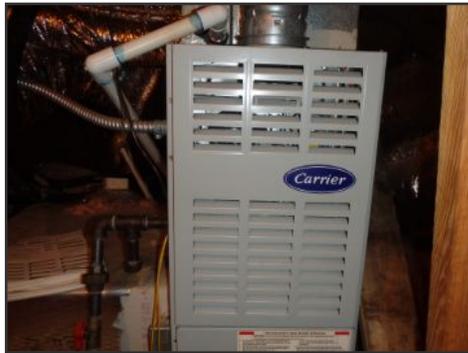
- 1.1. Appears normal. Heating system was operated during the inspection.
- 1.2. NEARING END OF LIFESPAN: It is noted that the furnace is nearing the end of its useful lifespan and should be monitored for replacement. HUD estimates typical lifespans to be 15-17 years for gas furnaces. Regular servicing is recommended. See service manual from manufacturer or contact NATE certified HVAC company. Aged furnaces can sometimes have hidden heat exchanger cracks that can be a carbon monoxide hazard.

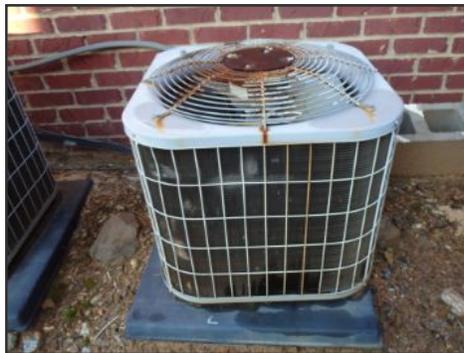
4.3. NOT LEVEL--CONDENSER: The condenser is not currently level. It should be made level so that internal parts stay properly lubricated. The Inspector advises the Client to arrange to have a licensed, NATE certified HVAC contractor further evaluate and address as necessary.

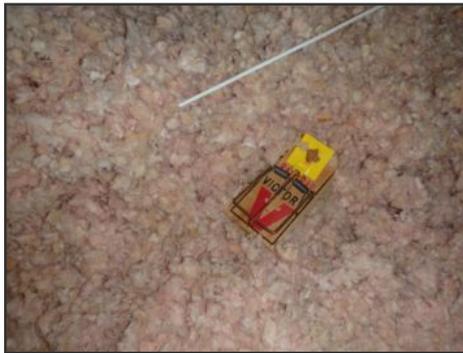
6.1. RODENTS--ATTIC: The Inspector observed rodent traps at the attic area of the home. Rodents can cause significant damage by chewing on circuits and ducts. Additionally, their urine and droppings can contain microbes that can be a health hazard. The Inspector advises the Client to arrange to have a professional pest control contractor further evaluate and address as necessary.

open rodent trap
