# Property Inspection REPORT

1234 Main Street, Decatur, GA 30030

INSPECTION PREPARED FOR: Atlanta Home Buyer

DATE OF INSPECTION: 8/21/2026

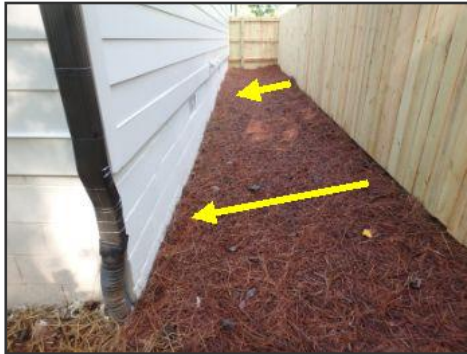
1.2. **REVERSE GRADING:** Slight reverse grading was observed at the foundation wall at side B (left)--back side. The soil incorrectly slopes back towards the foundation. General construction practice requires a positive slope away from the foundation for adequate drainage. It is recommended that the slope be at least 6" drop for 10' horizontally (or as far as possible where lot lines are limiting). The Inspector advises the Client to arrange to have a professional landscape contractor further evaluate and address as necessary. (IRC: R401.3 Drainage. Lots shall be graded to drain surface water away from foundation walls. The grade shall fall a minimum of 6 inches within the first 10 feet.)

slight reverse pitch toward foundation

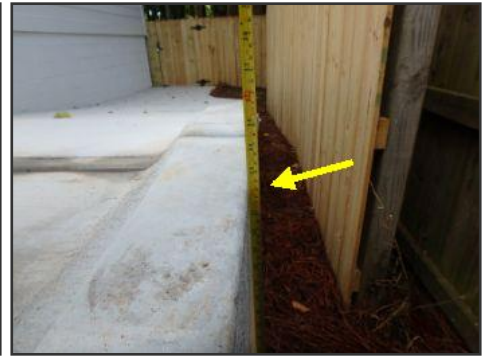
2.2. **ELEVATED DRIVEWAY SECTION:** The Inspector observed that the driveway is raised above grade along an approximately 12-foot linear portion at the right (Side D). In this section, the driveway surface is more than 30 inches above grade. This elevated condition presents a fall hazard. The Inspector advises the Client to arrange for a qualified contractor to install a protective guardrail or barrier at this section to reduce the risk of falls and improve safety (IRC R312 requires guards where walking surfaces are more than 30 inches above grade).

portion of driveway is over 30" from grade

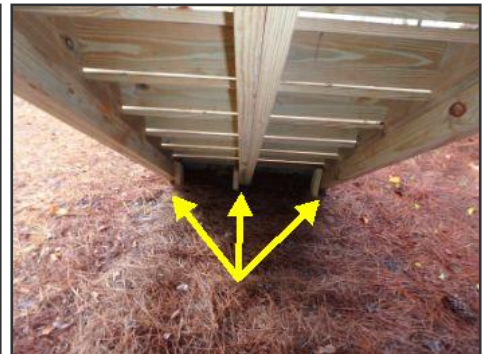
5.2. DECK STAIR STRINGER SUPPORT – BOTTOM: The Inspector observed that the stair stringers are not resting sufficiently on top of the landing. A full bearing of the stringer foot should be in contact with the landing surface to prevent detachment and ensure proper load transfer. The Inspector advises the Client to arrange for a professional contractor to further evaluate and make repairs as necessary.

missing concrete footing under stringers

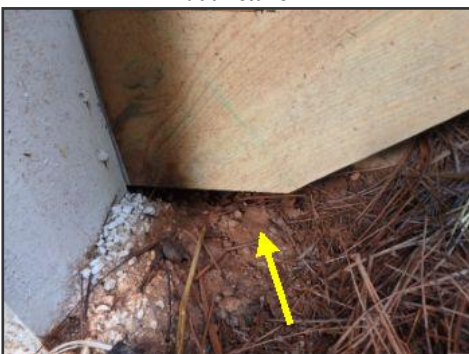
missing concrete footing under stringers

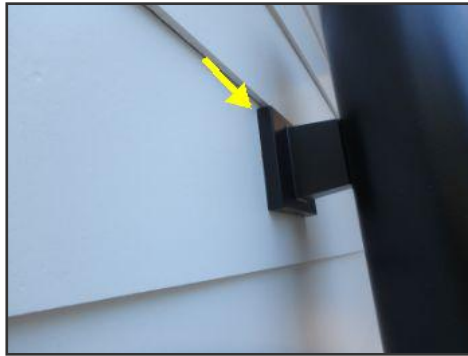
8.3. CAULK NEEDED AT EXTERIOR LIGHT FIXTURES: The Inspector observed that exterior lighting fixtures need to be caulked and sealed to wall. It is important to maintain the exterior paint and caulk as to protect the home from moisture deterioration. The Inspector advises the Client to arrange to have a professional painting contractor further evaluate and address as necessary.

*sealant needed at light fixtures' mounts*

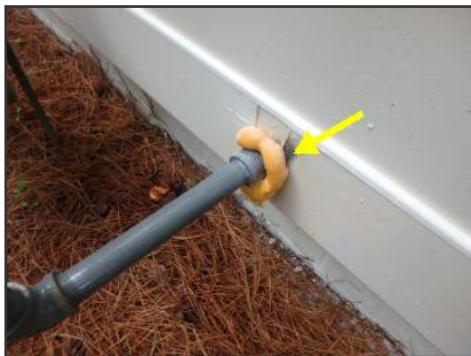
11.2. PENETRATIONS—SPRAY FOAM SEALANT: The Inspector observed spray foam sealant applied at annular spaces around gas pipe penetrations and PVC vent penetrations. Spray foam is not an approved fire-resistant material for sealing these types of penetrations and may conceal leaks or degrade with heat exposure. The Inspector advises the Client to arrange for a qualified contractor to remove the spray foam and properly seal penetrations with an approved, non-combustible, fire-rated material in accordance with manufacturer requirements and applicable codes.

*improper use of spray foam*

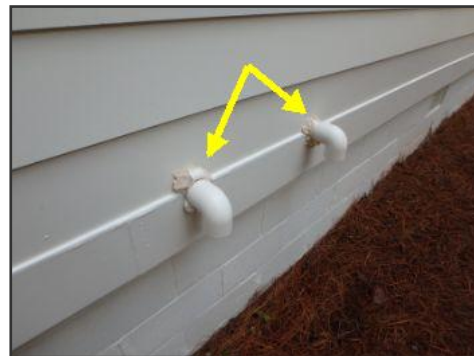
*improper use of spray foam*

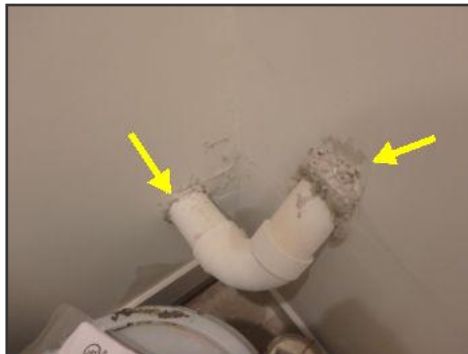
2.3. GARAGE-PVC PIPE PENETRATIONS: The Inspector observed spray foam sealant applied at annular spaces around PVC plumbing pipes penetrating the garage drywall. Spray foam is not an approved fire-resistant material for sealing penetrations in fire-resistance-rated assemblies, such as the common wall/ceiling between the garage and living space. The Inspector advises the Client to arrange for a qualified contractor to remove the spray foam and properly seal the penetrations with an approved fire-rated material in accordance with IRC R302.5 and manufacturer requirements.

*improper use of spray foam*

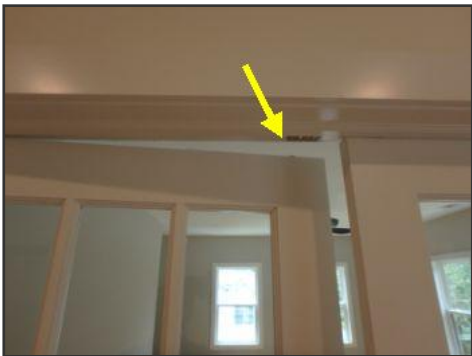
French door--deficient closure device

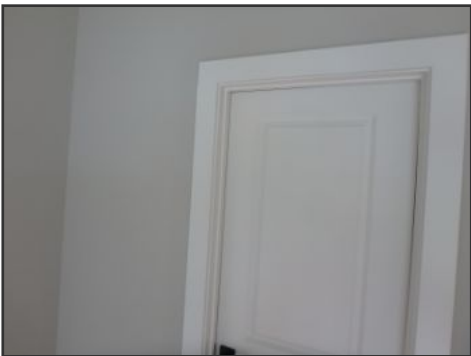
| Page 23 Item: 6 | Interior Doors | 6.2. BINDING--INTERIOR DOOR--BATHROOM: The Inspector observed that the front door to the Jack and Jill entry is sticking/binding and needs adjustments for proper operation. This is a minor concern that can be easily corrected. The Inspector advises the Client to arrange to have a professional contractor further evaluate and address as necessary.<br>6.3. BINDING--INTERIOR DOOR--CLOSET: The Inspector observed that the door to the main floor bedroom closet is sticking/binding and needs adjustments for proper operation. This is a minor concern that can be easily corrected. The Inspector advises the Client to arrange to have a professional contractor further evaluate and address as necessary.<br>6.4. WON'T LATCH--INTERIOR DOOR--FRENCH DOOR: The Inspector observed that the interior door for the French door (left side) does not latch properly; this is the upstairs bedroom at front right. This is a minor concern. The Inspector advises the Client to arrange to have a professional contractor further evaluate and address as necessary.<br>6.5. WON'T LATCH--INTERIOR DOOR--MASTER BATH: The Inspector observed that the interior door for the master bathroom does not latch properly. This is a minor concern. The Inspector advises the Client to arrange to have a professional contractor further evaluate and address as necessary. |

door binds--Jack and Jill bathroom

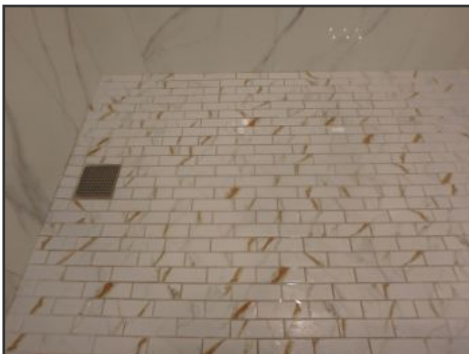
| Page 27 Item: 2 | Separate Shower | 2.3. SLOPE TOWARD DRAIN RECEPTOR--SHOWER FLOOR--MASTER BATHROOM: The Inspector observed a deficient shower floor slope. Water will pool on the shower floor as a result--this could cause a leak. The finished floor should slope uniformly towards the drain not less than 1/4 inch per foot [2%] nor more than 1/2". The Inspector advises the Client to arrange to have a professional contractor further evaluate and address as necessary. |

shower floor base

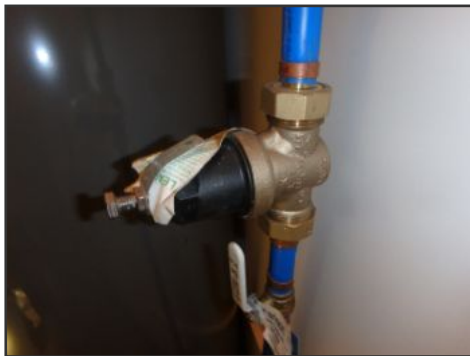
2.1. WATER PRESSURE TOO LOW: The Inspector tested with water pressure with a gauge and found it to be 36 psi. Adjustment or replacement of the water pressure control valve is recommended. Street pressure can also be tested by a plumber. The Inspector advises the Client to arrange to have a professional, licensed plumber further evaluate and address as necessary.

pressure reducing valve

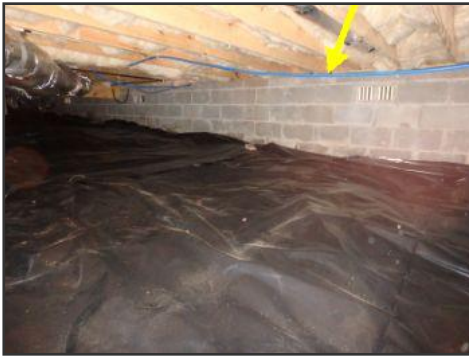
3.2. STRAPPING--PEX WATER LINES: The Inspector observed that the PEX water lines are not properly strapped; the lines should be strapped every 32" and at elbows at the crawl space. The Inspector advises the Client to arrange to have a professional plumbing contractor further evaluate and address as necessary.

sagging water pipe

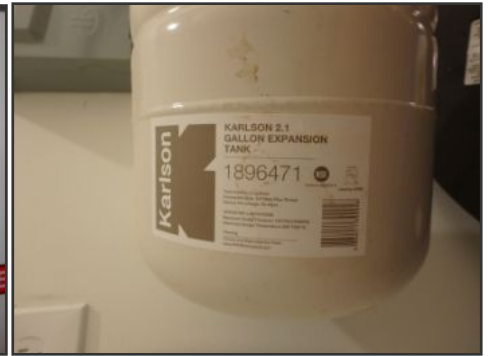
5.3. UNDERSIZED EXPANSION TANK: The Inspector observed that the expansion tank is only a Karlson brand 2.1 gallon fixture and is likely only rated for a single water heater up to 50 gallon capacity. Home has 80 gallon water heater. Expansion tanks reduce stress on water heaters and water pipes associated from normal expansion of heated water. The Inspector advises the Client to arrange to have a professional plumbing contractor further evaluate and address as necessary.

expansion tank

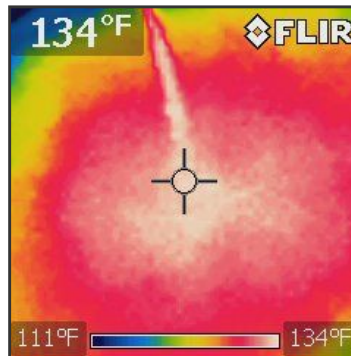
6.1. **HOT WATER TEMPERATURE TOO HIGH:** The hot water temperature was measured at 134° at the time of inspection. The temperature should be maintained at 120° or less for safety and reduced wear and tear on the pipes. Recommend adjusting thermostat; this is easy to do--see manual for directions.

hot water temperature

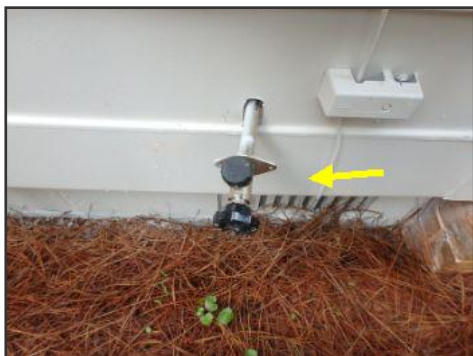
8.2. **FASTENING--HOSE FAUCETS:** The Inspector that water hose faucets should be secured to the exterior with screws to help prevent them from breaking; one at side B and one at side C are of concern. The Inspector advises the Client to arrange to have a professional, licensed plumber further evaluate and address as necessary.

*loose hose bib at side B*

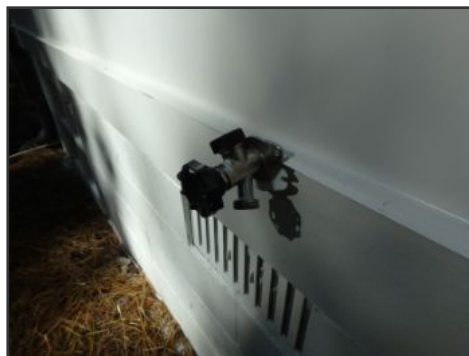
*loose hose bib--side C*

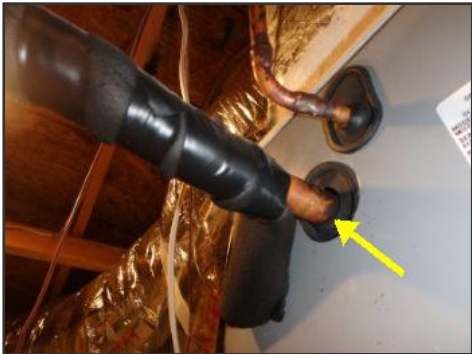
5.2. GAP--REFRIGERANT LINE INSULATION—NEAR COIL BOX--UPSTAIRS: The Inspector observed a gap at the insulation at the coil box. It should be replaced/sealed to prevent moisture damage from dripping condensation. This is an easy correction. The Inspector advises the Client to arrange to have a professional, NATE certified HVAC contractor further evaluate and address as necessary.

insulation gap

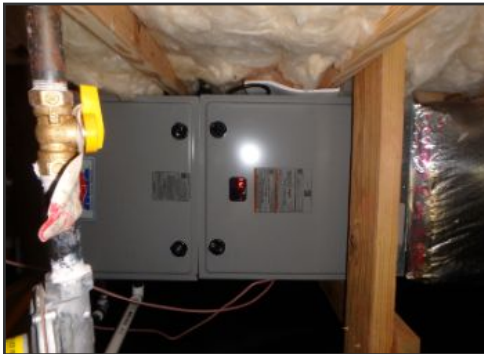
1.2. INOPERATIVE--GAS FURNACE--MAIN: The Inspector observed that the gas furnace is inoperative. The cause could not be readily determined. The Inspector uses normal operating controls (thermostat) when testing HVAC equipment. The Inspector advises the Client to arrange to have a professional, NATE certified HVAC contractor further evaluate and address as necessary.

Heil brand furnace

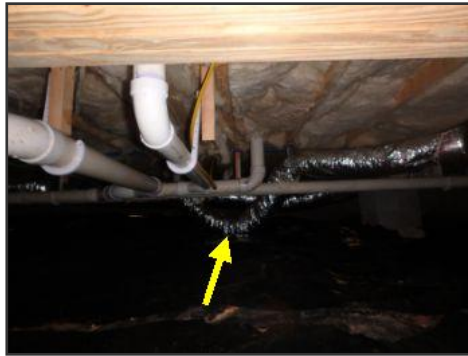
3.2. HVAC--SAGGING FLEX DUCT: The Inspector observed a sagging flex supply duct in the center of the crawlspace. Improperly supported ducts can restrict airflow, reduce system efficiency, and place stress on duct connections. The Inspector advises the Client to have a qualified HVAC contractor properly secure the duct with approved hangers or strapping in accordance with manufacturer requirements and mechanical code.

sagging duct

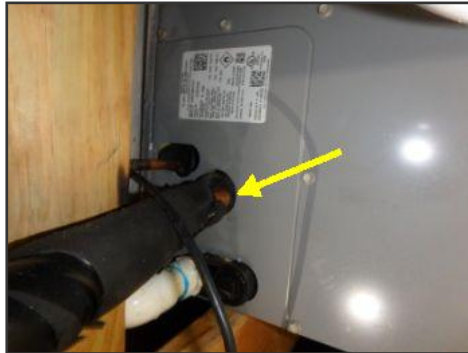
5.2. GAP--REFRIGERANT LINE INSULATION--NEAR COIL BOX--MAIN: The Inspector observed a gap at the insulation at the coil box. It should be replaced/sealed to prevent moisture damage from dripping condensation. This is an easy correction. The Inspector advises the Client to arrange to have a professional, NATE certified HVAC contractor further evaluate and address as necessary.

*insulation gap*

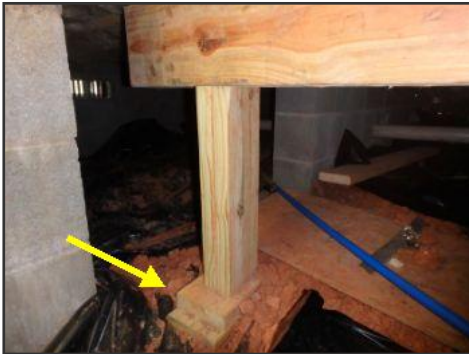
5.2. CRAWL SPACE-IMPROPER SUPPORT: The Inspector observed a two-ply 2x6 support post located at the front of the home, approximately under the foyer, supporting the girder tail. The post is resting on stacked blocks of scrap wood directly on the soil. This is not a proper load-bearing installation and does not provide a stable or permanent foundation. Posts of this type should be supported by a properly sized, poured-in-place concrete footing to distribute loads adequately and prevent settlement. The Inspector advises the Client to have a qualified contractor install a code-compliant footing and properly reset the support post.

deficient girder support
