# Property Inspection REPORT

1000 Any Street, Atlanta, GA 30301

DATE OF INSPECTION: 5/13/2026

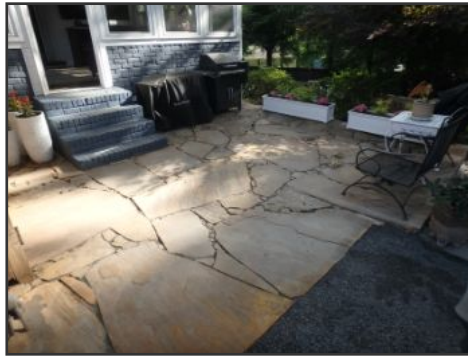
4.2. STONE PATIO / WALKWAY SURFACE: The flagstone patio/walkway surface appeared generally serviceable at the time of inspection. Common open joints and irregular gaps between stones were noted, which are typical of this type of installation. No major concerns were observed; routine maintenance may be needed over time to manage joint fill, vegetation growth, or minor movement of individual stones.

patio

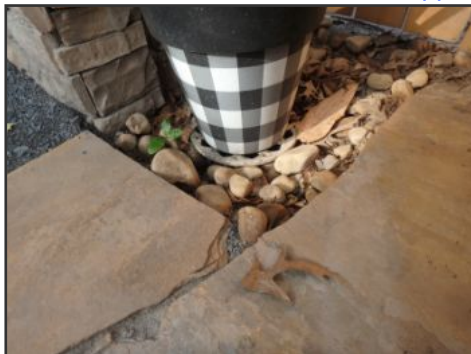
5.3. SURFACE DRAIN – PATIO AREA: A surface area drain/catch basin was observed adjacent to the patio near the exterior wall. This drain appears intended to collect surface water runoff and convey it away from the structure through an underground drain line. Functional performance could not be confirmed at the time of inspection. Recommend confirming the drain is free of obstruction, properly connected, and discharging adequately away from the foundation to help reduce the potential for moisture intrusion or localized foundation settlement.

catch basin

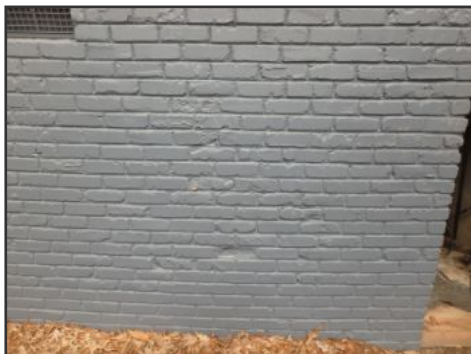
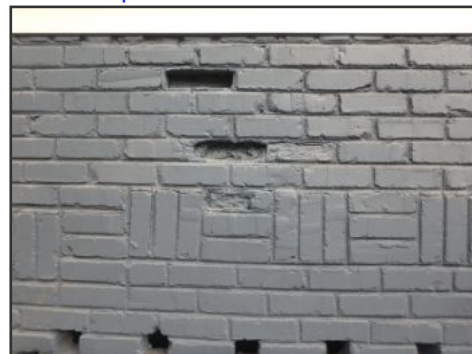
3.3. BRICK VENEER / MASONRY WALL: Localized areas of brick face deterioration (spalling) was observed at portions of the exterior masonry wall. No significant displacement or obvious structural movement was noted at the visible areas at the time of inspection. This condition appears localized and is commonly associated with long-term moisture exposure, aging, or prior coating/repair materials. Monitor for progression and repair deteriorated masonry surfaces as needed during routine maintenance to help limit further deterioration.

example brick spalling

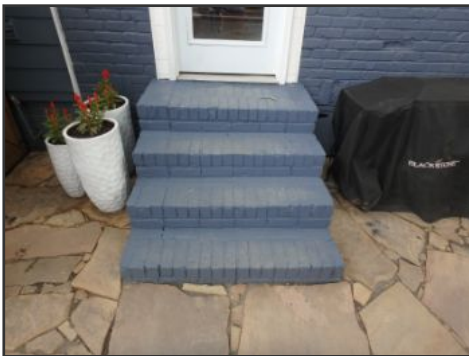
| Building Exterior | | |
|---|---|---|
| Page 16 Item: 5 | Steps, Stairways and Railings Condition | 5.3. GRIPPABLE HANDRAIL: The inspector did not observe a handrail at the exterior masonry steps serving the steps at side D (right). Handrails are important safety features that help reduce the risk of falls, particularly where multiple risers are present. Installation of a properly sized grippable handrail is recommended for improved safety. The inspector advises the client to arrange for further evaluation and correction by a qualified contractor as needed. (IRC R311.7.8) |

5.3. GRIPPABLE HANDRAIL: The inspector did not observe a handrail at the exterior masonry steps serving the steps at side D (right). Handrails are important safety features that help reduce the risk of falls, particularly where multiple risers are present. Installation of a properly sized grippable handrail is recommended for improved safety. The inspector advises the client to arrange for further evaluation and correction by a qualified contractor as needed. (IRC R311.7.8)

secondary steps--side D

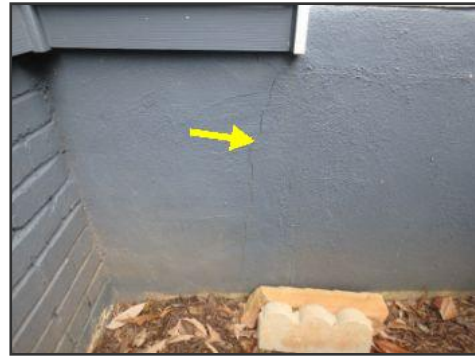
hairline crack--porch foundation

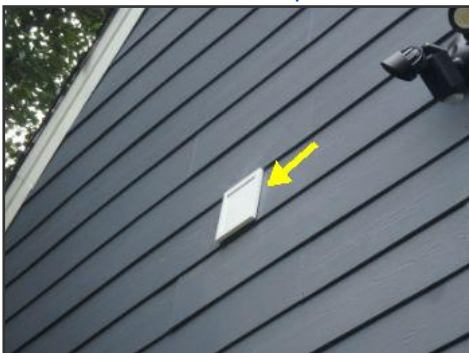
10.3. **WEATHER HEAD--NOT SEALED TO WALL:** The Inspector observed that a weather head at side B (left) at the gable of the building is not sealed to the wall with caulk to prevent water entry inside the wall. Weather heads at exterior walls should be tightly connected and sealed with caulk to prevent water intrusion. The Inspector advises the Client to arrange to have a professional contractor further evaluate and address as necessary.

sealant needed--side B

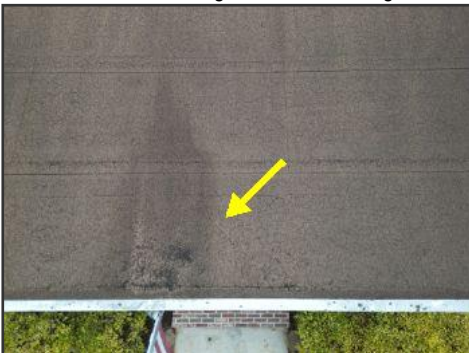
**1.2. ROLLED ROOFING – LOW-SLOPE FRONT PORCH SECTION:** The rolled roofing material at the front porch exhibited advanced age-related weathering including widespread surface crazing/alligatoring, drying, and general wear consistent with prolonged exposure. A localized darkened area was observed that may be consistent with an area of past moisture retention or ponding, resulting in accelerated surface wear. No active leakage was confirmed at the time of inspection. The observed condition indicates aging material with reduced remaining service life; continued monitoring and budgeting for repair or replacement should be anticipated.

excess wear--front porch

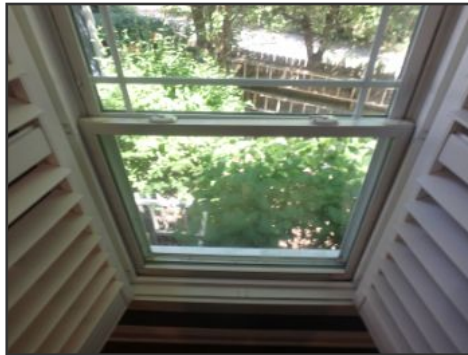
| Interior | | |
|---|---|---|
| Page 21 Item: 4 | Windows Condition | 4.2. THERMAL SEAL RUPTURE—WINDOW: The Inspector observed a window sash unit with a failed thermal seal at the master bedroom at side B. This condition is the likely cause of the visible haze or fogging between the glass panes. While this is primarily a cosmetic concern, the window has lost some of its intended insulating and energy-efficiency performance. The Inspector advises the Client to arrange for further evaluation and correction by a qualified contractor as desired. |

4.2. THERMAL SEAL RUPTURE—WINDOW: The Inspector observed a window sash unit with a failed thermal seal at the master bedroom at side B. This condition is the likely cause of the visible haze or fogging between the glass panes. While this is primarily a cosmetic concern, the window has lost some of its intended insulating and energy-efficiency performance. The Inspector advises the Client to arrange for further evaluation and correction by a qualified contractor as desired.

*thermal seal rupture*

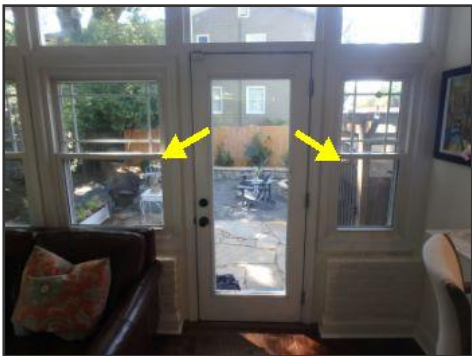
| Interior | | |
|---|---|---|
| Page 21 Item: 5 | Safety Glazing (Tempered Glass) | 5.2. WINDOW GLAZING – SAFETY CONCERN: Windows immediately adjacent to the exterior door at the Side D sunroom appear to contain non-tempered glazing despite being located within the hazardous location zone near the door. Modern safety standards require tempered safety glass in this location to reduce the risk of injury from accidental human impact and glass breakage. Recommend replacement with approved tempered safety glazing by a qualified contractor for improved occupant safety. |

5.2. WINDOW GLAZING – SAFETY CONCERN: Windows immediately adjacent to the exterior door at the Side D sunroom appear to contain non-tempered glazing despite being located within the hazardous location zone near the door. Modern safety standards require tempered safety glass in this location to reduce the risk of injury from accidental human impact and glass breakage. Recommend replacement with approved tempered safety glazing by a qualified contractor for improved occupant safety.

windows should have tempered glazing

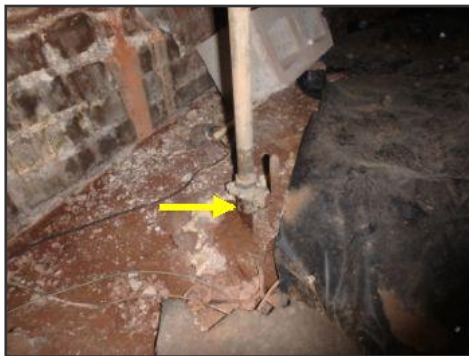
| Interior | | |
|---|---|---|
| Page 29 Item: 1 | Main Water Valve | 1.1. MAIN WATER SHUTOFF VALVE: The main water shutoff valve exhibited heavy corrosion/rusting and a minor active leak was observed at the time of inspection. Deteriorated shutoff valves may fail to operate properly when needed or may worsen over time, resulting in increased leakage or failure. Recommend replacement by a qualified plumbing contractor. |

1.1. MAIN WATER SHUTOFF VALVE: The main water shutoff valve exhibited heavy corrosion/rusting and a minor active leak was observed at the time of inspection. Deteriorated shutoff valves may fail to operate properly when needed or may worsen over time, resulting in increased leakage or failure. Recommend replacement by a qualified plumbing contractor.

*rusted and leaking main valve*

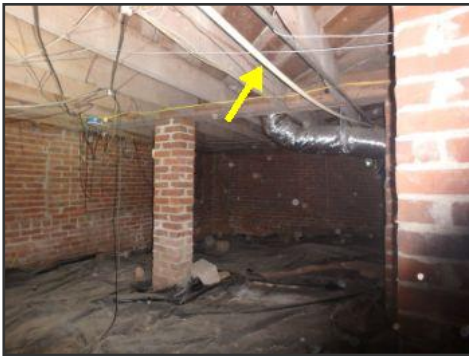
3.2. STRAPPING--CPVC: The Inspector observed that the CPVC water lines are not properly strapped at some locations; the lines should be strapped every 36" and at elbows. The Inspector advises the Client to arrange to have a professional plumbing contractor further evaluate and address as necessary.

example sagging pipe

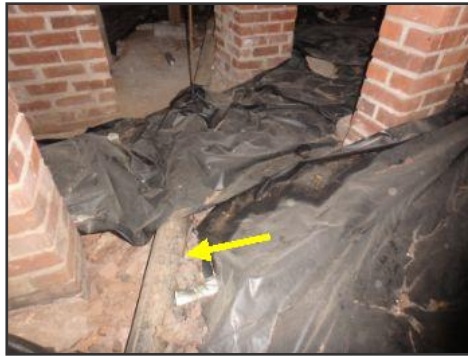
| Interior | | |
|---|---|---|
| Page 30 Item: 4 | Drain/Waste/Vent Piping | 4.2. SEWER LATERAL – CAST IRON – AGED: The visible sewer lateral appears to be cast iron piping, which is considered an older drainage material that is commonly at or beyond its typical service life in homes of this age. No active backups or drainage performance concerns were noted or reported by the seller at the time of inspection; however, cast iron drain piping commonly deteriorates internally over time due to corrosion, scaling, and wall loss. Based on the apparent age, this sewer lateral is likely nearing the end of its useful service life, and the client should anticipate replacement in the foreseeable future. Further evaluation by a qualified plumbing contractor is recommended as needed. |

4.2. SEWER LATERAL – CAST IRON – AGED: The visible sewer lateral appears to be cast iron piping, which is considered an older drainage material that is commonly at or beyond its typical service life in homes of this age. No active backups or drainage performance concerns were noted or reported by the seller at the time of inspection; however, cast iron drain piping commonly deteriorates internally over time due to corrosion, scaling, and wall loss. Based on the apparent age, this sewer lateral is likely nearing the end of its useful service life, and the client should anticipate replacement in the foreseeable future. Further evaluation by a qualified plumbing contractor is recommended as needed.

cast iron drain pipe

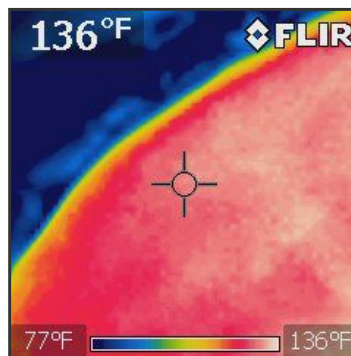
6.1. **HOT WATER TEMPERATURE TOO HIGH:** The hot water temperature was measured at 136° at the time of inspection. The temperature should be maintained at 120° or less for safety and reduced wear and tear on the pipes. Recommend adjusting thermostat; this is easy to do--see manual for directions.

hot water temperature

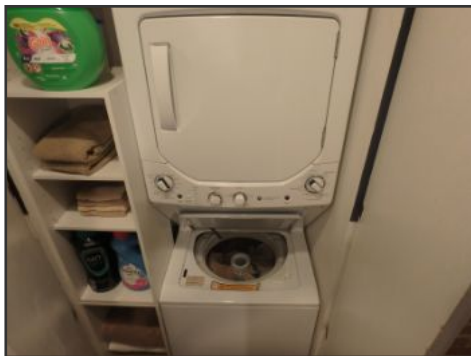
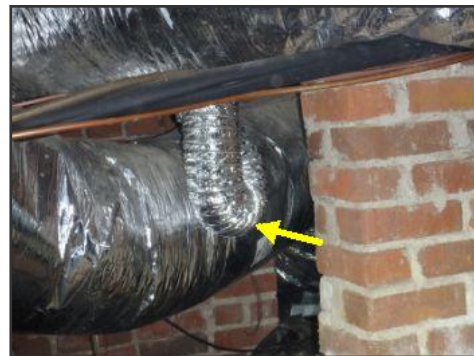
9.4. DRYER DUCT--IMPROPER USE OF FLEX DUCT--UNDERFLOOR: The dryer duct is improper flexible material. Only smooth, rigid dryer ducts should be installed at underfloor area. Dryer ducts should be 25' or less (reduce allowable length by 5' for every 90° elbow). It is recommended to change the duct to the correct material to reduce fire hazard. The Inspector advises the Client to arrange to have a professional contractor further evaluate and address as necessary.

*improper dryer duct material*

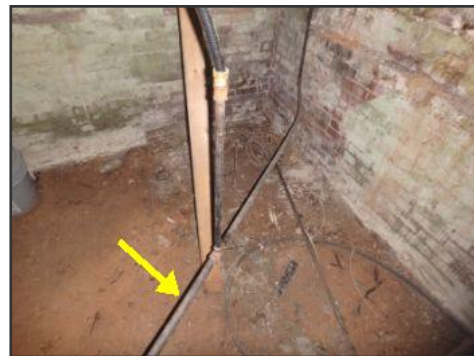
| Page 34 Item: 10 | Gas Supply Piping | <p>10.3. GAS SUPPLY PIPING – SUPPORTS: Gas supply piping observed in the cellar/underfloor area lacked adequate support at visible areas. Gas piping should be properly braced or supported at appropriate intervals (commonly approximately every 6 feet for horizontal runs) to reduce movement, stress at fittings, and potential damage over time. Recommend adding proper supports as needed.</p> |

10.3. GAS SUPPLY PIPING – SUPPORTS: Gas supply piping observed in the cellar/underfloor area lacked adequate support at visible areas. Gas piping should be properly braced or supported at appropriate intervals (commonly approximately every 6 feet for horizontal runs) to reduce movement, stress at fittings, and potential damage over time. Recommend adding proper supports as needed.

deficient support gas pipe

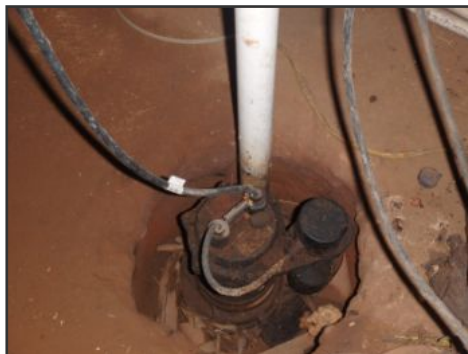
| Page 34 Item: 11 | Sump Pump(s) | <p>11.1. SUMP PUMP – IMPROPER LOCATION / AGED: A sump pump is present in the cellar/underfloor area; however, it is not located at the apparent lowest point of the space, and standing water—likely stormwater intrusion—was observed in areas not effectively served by the current installation. As configured, the pump may not adequately manage water accumulation in this area. Recommend creating a new sump pit at the lowest practical point of the cellar/underfloor area and relocating or replacing the sump pump as part of this corrective work, as the existing pump appears aged and may be near the end of its useful service life.</p> |

11.1. SUMP PUMP – IMPROPER LOCATION / AGED: A sump pump is present in the cellar/underfloor area; however, it is not located at the apparent lowest point of the space, and standing water—likely stormwater intrusion—was observed in areas not effectively served by the current installation. As configured, the pump may not adequately manage water accumulation in this area. Recommend creating a new sump pit at the lowest practical point of the cellar/underfloor area and relocating or replacing the sump pump as part of this corrective work, as the existing pump appears aged and may be near the end of its useful service life.

sump pump condition

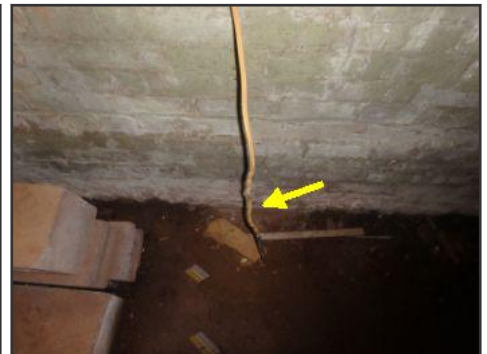
abandoned circuit

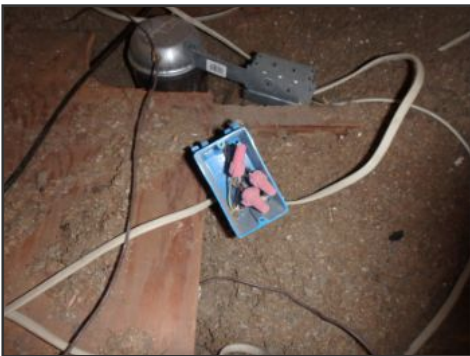
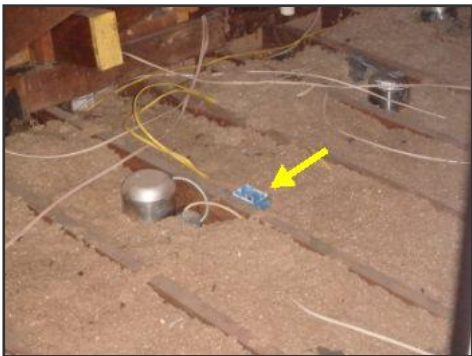
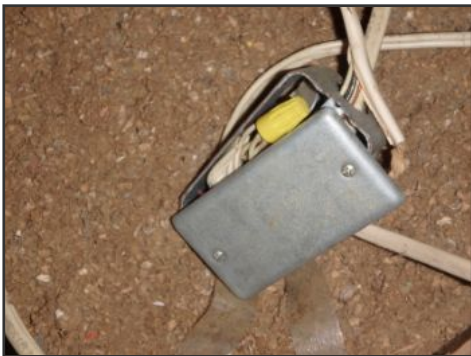
| Page 37 Item: 7 | Branch Circuits | <p>7.2. ATTIC ELECTRICAL WIRING: Multiple junction boxes were observed in the attic with improper conditions including unsecured/open junction boxes and wiring not consistently protected or properly secured at visible areas. Branch circuit wiring was also observed loosely draped across attic framing and insulation rather than being properly supported in a neat and workmanlike manner. These conditions present an increased risk of wiring damage and electrical safety concerns. Recommend correction by a qualified electrical contractor.</p> <p>7.3. ABANDONED / UNUSED ELECTRICAL WIRING—OBSERVED: Abandoned or unused electrical wiring was observed, including examples in the cellar area, with additional unused conductors noted in the attic. Unused electrical wiring should be properly terminated, removed, or otherwise made safe in accordance with accepted electrical practices to reduce the potential for confusion, accidental energization concerns, or other safety issues. The Inspector recommends evaluation and correction by a qualified, licensed electrician.</p> <p>7.4. OPEN JUNCTION BOX—CRAWL SPACE: The Inspector observed one open electrical junction box in the crawl space beneath the home. Junction boxes should be properly enclosed with an approved cover plate to protect wiring connections from accidental contact, physical damage, and other electrical safety concerns. This is generally a minor condition that can be readily corrected. The Inspector advises the Client to arrange to have a professional, licensed electrician further evaluate and address as necessary.</p> |

improper junction--attic

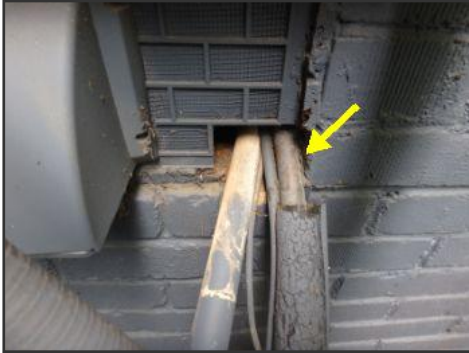
5.2. HVAC REFRIGERANT LINE INSULATION—DAMAGED / INCOMPLETE: The exterior refrigerant suction line insulation serving the HVAC system is damaged, deteriorated, and incomplete in areas, leaving portions of the refrigerant line exposed. Missing or compromised insulation can reduce system efficiency, contribute to unnecessary energy loss, and may promote condensation-related deterioration over time. The Inspector recommends replacement of the damaged insulation to fully protect the exposed refrigerant line.

insulation gap

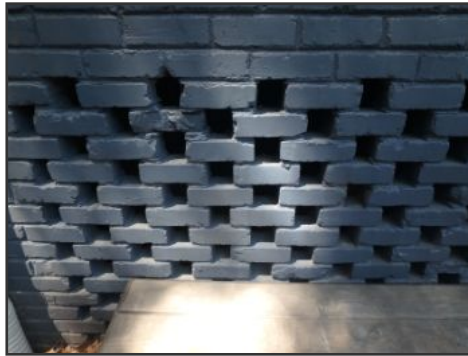
| Page 44 Item: 3 | Foundation Walls Condition | <p>3.2. SUNROOM ENCLOSURE SKIRTING—OPEN MASONRY ALLOWING PEST ENTRY: The enclosed sunroom is now part of the home's heated and cooled living space; however, the open decorative masonry skirting below this area does not adequately separate the common crawl space from exterior conditions. The numerous open brick voids can allow pest entry, air infiltration, and moisture intrusion beneath the enclosed space. Improvement is recommended to properly enclose this area with an appropriate screened or sealed barrier while maintaining any required crawl space ventilation where applicable.</p> |

3.2. SUNROOM ENCLOSURE SKIRTING—OPEN MASONRY ALLOWING PEST ENTRY: The enclosed sunroom is now part of the home's heated and cooled living space; however, the open decorative masonry skirting below this area does not adequately separate the common crawl space from exterior conditions. The numerous open brick voids can allow pest entry, air infiltration, and moisture intrusion beneath the enclosed space. Improvement is recommended to properly enclose this area with an appropriate screened or sealed barrier while maintaining any required crawl space ventilation where applicable.

open brick

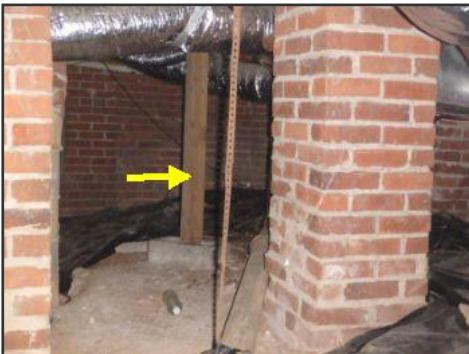
4.4. AUXILIARY STEEL JACK POSTS: Approximately 3 adjustable steel jack posts were observed in the crawlspace. These types of posts are generally considered temporary unless specifically listed/labeled for permanent structural use. Visible installation conditions suggest further evaluation is warranted to confirm proper support, footing, and suitability for permanent structural use. Recommend correction by a qualified contractor as needed.

substandard floor support column

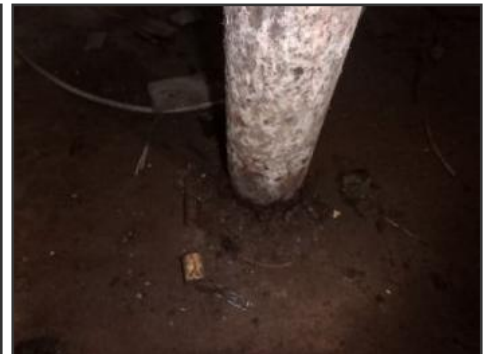
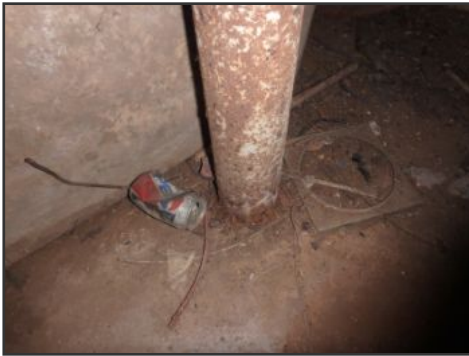
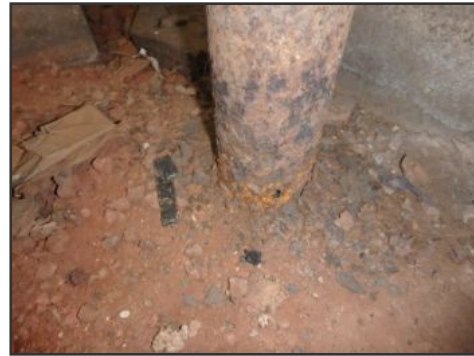
rusted steel column example

*rusted steel column example*

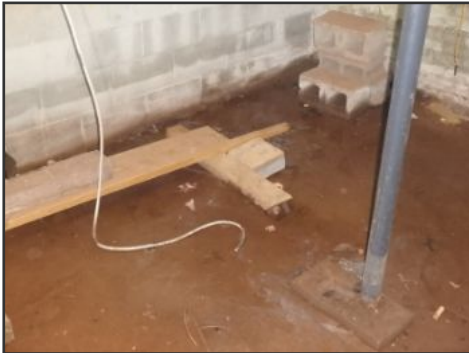
**5.1. ACTIVE MOISTURE AT CELLAR:** Active moisture intrusion was observed within the cellar area, with evidence of water seepage through portions of the foundation walls and/or slab perimeter. Persistent moisture conditions can contribute to elevated humidity, organic microbial growth, deterioration of wood framing and stored materials, corrosion of metal components, and general adverse crawl space/cellar conditions over time. Moisture management improvements are recommended. The Inspector advises the Client to arrange for a qualified contractor to further evaluate the source of moisture intrusion and recommend appropriate corrective measures. (IRC: R408.6)

*standing water*

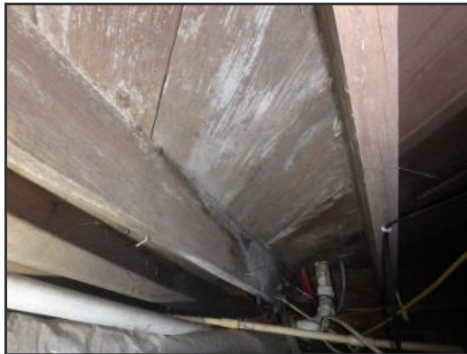
prior leak noted

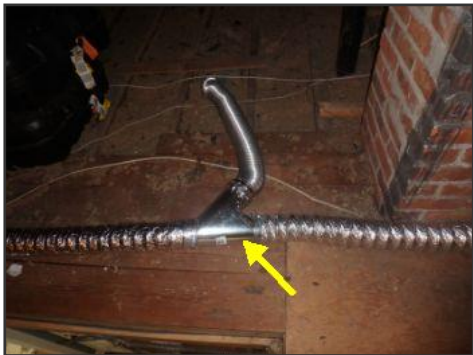
5.3. BATHROOM EXHAUST VENTING: Two bathroom exhaust fans appear to discharge into a shared duct system within the attic. Shared exhaust duct configurations can contribute to reduced airflow performance and potential backdrafting of moist air between bathrooms if not specifically designed for this application. Recommend evaluation and correction by a qualified contractor as needed; separate independently terminated exhaust ducts are generally preferred.

bathroom vent ducts improper tie together
