# The Inspection Company, LLC

## Property Inspection Report

124 Any Street, Atlanta, GA 30307  
Inspection prepared for: John Q. Client  
Date of Inspection: 4/18/2013 Time: 1:40 PM  
Age of Home: 1 year Size: 2,300 SF  
Weather: 79°, partly cloudy

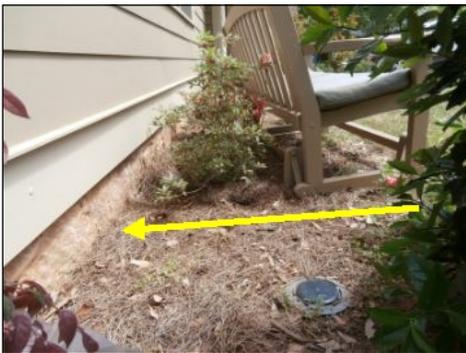
1.1. **REVERSE GRADING:** Reverse grading was observed at the foundation wall at side A. The soil incorrectly slopes back towards the foundation. General construction practice requires a positive slope away from the foundation for adequate drainage. It is recommended that the slope be at least 6" drop for 10' horizontally. The Inspector advises the Client to arrange to have a professional landscape contractor further evaluate and address as necessary.

*reverse grading*

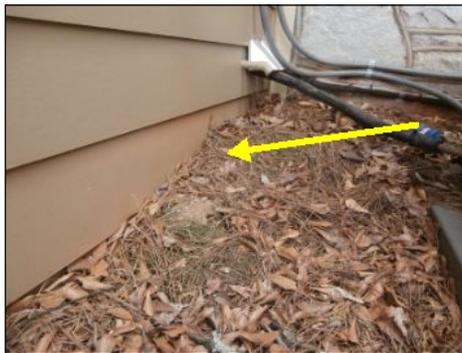
1.2. **GRADE TOO CLOSE TO SIDING:** The Inspector observed that the grade is too close to the bottom edge of the exterior cladding at side C (near air conditioning units). There should be a 6" clearance between the bottom edge of siding and the top of the mulch. The Inspector advises the Client to arrange to have a professional contractor further evaluate and address as necessary.

*grade is too high*

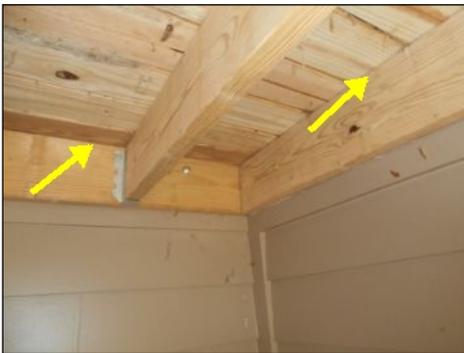
no visible flashing at deck attachment

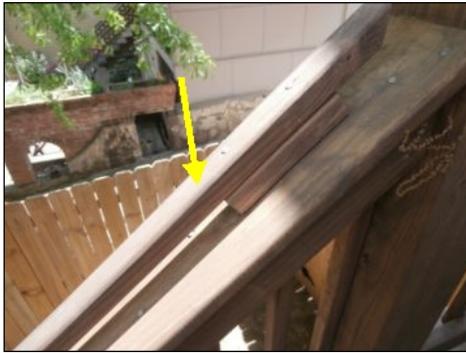
6.2. LOOSE HANDRAIL AT DECK: The handrail at the deck is loose and could detach. It is recommended to install 4" lag screws to provide better connection for safety. The Inspector advises the Client to arrange to have a professional contractor further evaluate and address as necessary.

*loose handrail*

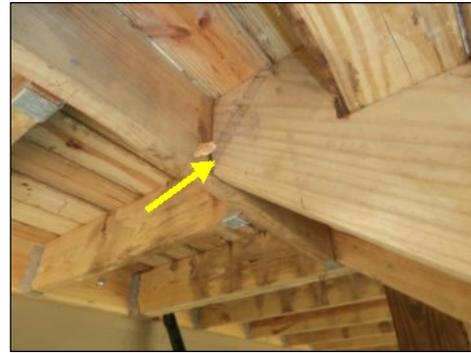
Page 7 Item: 6	Stairs & Handrail	<p>6.1. STRINGER ATTACHMENT FOR DECK STEPS TO FLOOR: The Inspector did not observe adequate connection of the stringers to the deck floor system. Current building practice requires installation of 600 lb. rated metal brackets to connect the stringers. This is an easy, but important correction to prevent possible detachment. The Inspector advises the Client to arrange to have a professional contractor further evaluate and address as necessary.</p> <p>6.2. LOOSE HANDRAIL AT DECK: The handrail at the deck is loose and could detach. It is recommended to install 4" lag screws to provide better connection for safety. The Inspector advises the Client to arrange to have a professional contractor further evaluate and address as necessary.</p> <p>6.3. STEP TREADS: Nails are inadequate at the step treads; this could cause detachment or a trip hazard. The Inspector advises the Client to arrange to have a professional contractor further evaluate and address as necessary.</p>

*missing brackets at stringers*

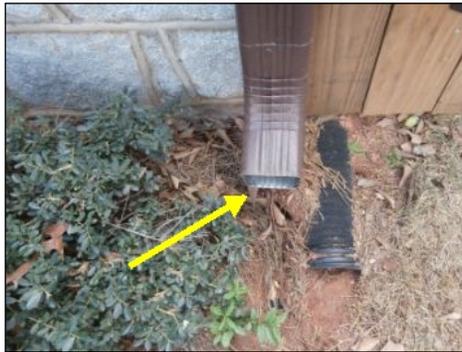
7.2. EXTENSION PIPES: The home's downspout needs an extension pipe where missing at side C. It is important to drain storm water away from the foundation of the structure so it does not cause damage by softening the soil under the foundation.

*extension pipe is needed*

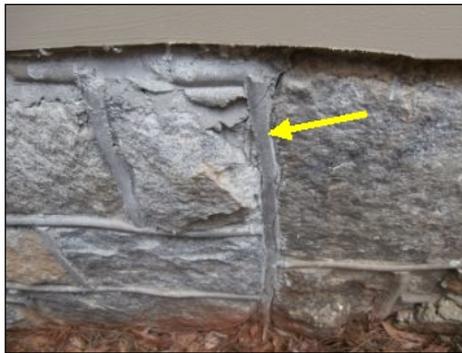
2.1. FOUNDATION WALL HAIRLINE CRACKS: Typical, minor hairline cracks were observed and likely caused by minor differential settlement of the home's foundation. The cracks should be grouted with mortar and monitored over time. They do not appear to represent a significant concern. The Inspector advises the Client to arrange to have a professional contractor further evaluate and address as necessary.

*example very minor hairline crack*

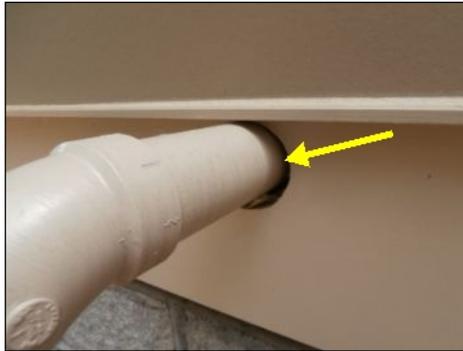
7.3. CAULK GAPS: The Inspector observed gaps around the pipe penetrations at the exterior walls. The annular spaces (gaps) should be sealed with an elastomeric caulk to prevent water entry and damage. This is a minor concern. The Inspector advises the Client to arrange to have a professional contractor further evaluate and address as necessary.

*caulk is needed*

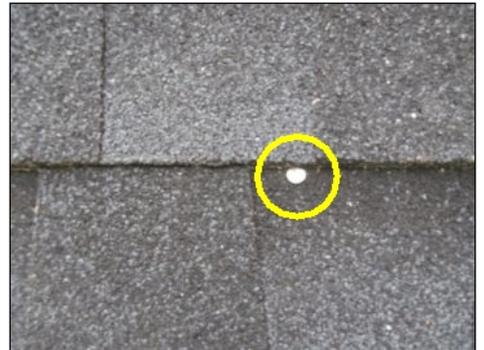
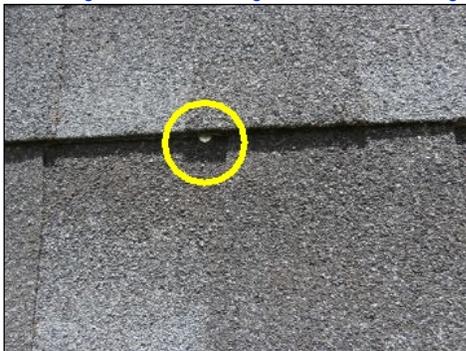
- 1.1. Appears normal. Normal conditions at time of inspection.
- 1.2. NAIL HEADS: The Inspector observed some limited areas of exposed, rusted nail heads at the roof covering. They should be sealed with roofing mastic. This is a minor concern that can be easily addressed. The Inspector advises the Client to arrange to have a professional certified roofing contractor further evaluate and address as necessary.

example exposed nail head

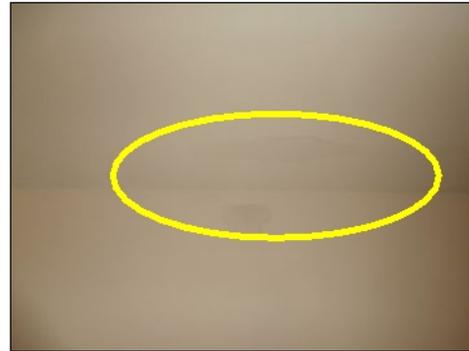
3.1. **CEILING MOISTURE STAINS:** The Inspector observed moisture stains on the ceiling(s) at the following locations: and bedroom--downstairs. The stains appeared to be dry at the time of inspection as checked with a Flir infrared camera. The concern is cosmetic but the area should be monitored. The Inspector advises the Client to arrange to have a professional contractor further evaluate and address as necessary.

*moisture stain--master bedroom*

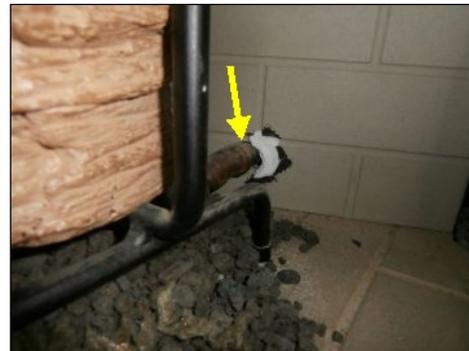
Interior Elements		
Page 15 Item: 3	Fireplace Condition	3.3. SEAL GAP AT GAS LINE PENETRATION: The Inspector observed A gap around the gas pipe penetration at the firebox. The annular space (gap) should be sealed with a fire-rated sealant for safety. This is easily correctable. Inspector advises the Client to arrange to have a professional contractor further evaluate and address as necessary.
Page 16 Item: 4	Damper Condition	4.2. SAFETY CLIP: The Inspector did not observe a safety clip at the damper. This is recommended for dampers where gas logs are used at fireplaces. Clips reduce possible carbon monoxide hazard. The Inspector advises the Client to arrange to have a professional contractor further evaluate and address as necessary.
Kitchen		
Page 25 Item: 8	Countertop Receptacles	8.2. LACKING COUNTER AREA RECEPTACLE(S): The Inspector observed that the kitchen countertop is not adequately served with receptacles per current standards. A receptacle should be available to serve each 2' section of a counter. One is missing at side B (far left of sink area). The Inspector advises the Client to arrange to have a professional, licensed electrician further evaluate and address as necessary for safety.

3.1. Appears normal.  
 3.2. Appears normal. Gas logs were tested and appeared to function as intended.  
 3.3. **SEAL GAP AT GAS LINE PENETRATION:** The Inspector observed A gap around the gas pipe penetration at the firebox. The annular space (gap) should be sealed with a fire-rated sealant for safety. This is easily correctable. Inspector advises the Client to arrange to have a professional contractor further evaluate and address as necessary.

*proper sealant should be installed*

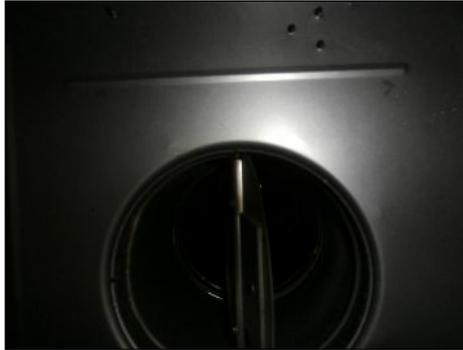
4.2. SAFETY CLIP: The Inspector did not observe a safety clip at the damper. This is recommended for dampers where gas logs are used at fireplaces. Clips reduce possible carbon monoxide hazard. The Inspector advises the Client to arrange to have a professional contractor further evaluate and address as necessary.

safety clamp is needed

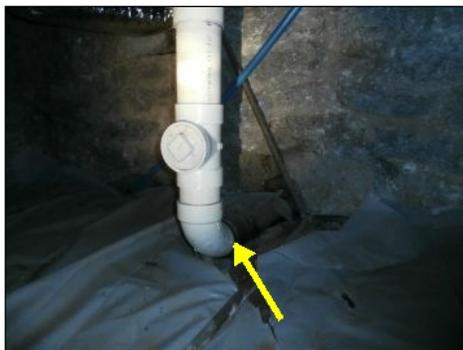
4.2. CAST IRON PIPE: The home has most of the cast iron main drain line in use. While the system still appears to be serviceable, there may be concealed deterioration inside the pipe and underground. The Inspector cannot predict the remaining useful lifespan of the pipe. The pipe should be monitored in the meantime.

*main waste line transition to cast iron*

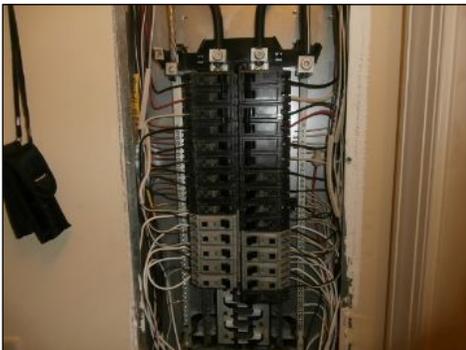
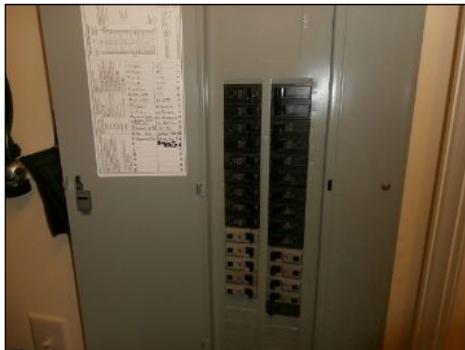
5.2. **PANELBOARD LOCATED INSIDE CLOSET:** The Inspector observed that the distribution panel is located in a small closet under the stairs. Current electrical standards prohibit installation of panelboards inside closets. The panel should be used with caution unless it is moved. The Inspector advises the Client to arrange to have a professional, licensed electrician further evaluate and address as necessary. (240.24 Location in or on Premises (D) Not in Vicinity of Easily Ignitable Material -Overcurrent devices shall not be located in the vicinity of easily ignitable material, such as in clothes closets. Examples of locations where combustible materials may be stored are linen closets, paper storage closets, and clothes closets.)

distribution panel

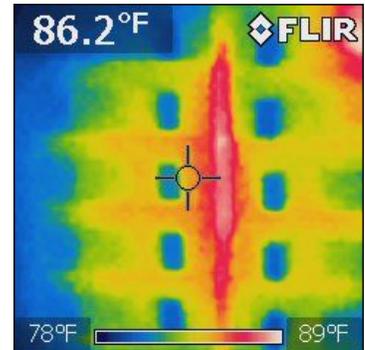
normal infrared scan of distribution panel

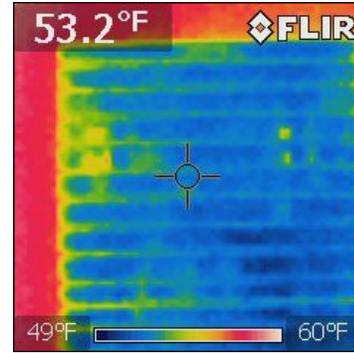
4.1. Appears normal. The air conditioner was operated for at least 30 minutes. It functioned normally at time of inspection by producing an acceptable temperature drop.

normal temperature drop

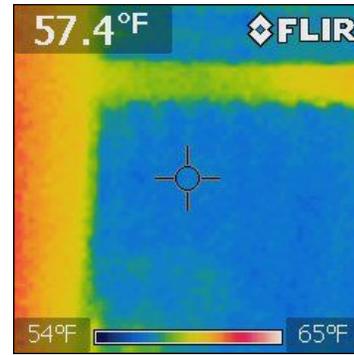
Location: *Upstairs.*  
 Observations:  
 4.1. *Appears normal. The air conditioner was operated for at least 30 minutes. It functioned normally at time of inspection by producing an acceptable temperature drop.*

normal temperature drop
