The Inspection Company, LLC

Property Inspection Report

123 Any Street, Smyrna, GA 30080
Inspection prepared for: John Q. Customer
Real Estate Agent: Jane A. Agent - ABC Realty Company

Date of Inspection: 1/16/2015 Time: 9:00 AM
Age of Home: 12 years | Size: 3,455 SF estimated
Weather: 41°, sunny, recent rain

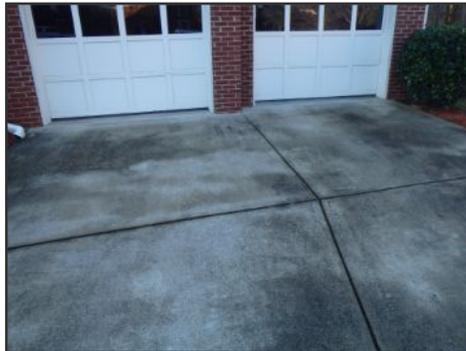
general image of driveway

Observations:
 2.1. Appears normal.
 2.2. Minor, hairline cracks present.

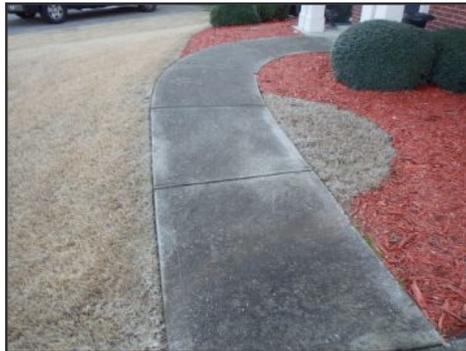
front walkway

Observations:
 3.1. Appears normal.
 3.2. Minor, hairline cracks present.

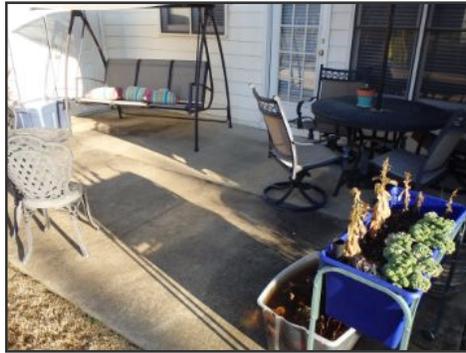
general image of patio

Observations:
 4.1. Appears normal.
 4.2. Minor, hairline cracks present.

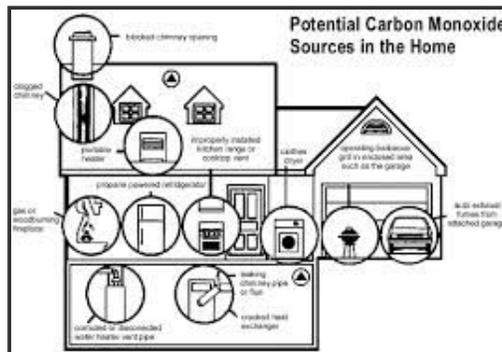
understanding carbon monoxide hazards

2.1. CARBON MONOXIDE DETECTORS NEEDED: Carbon monoxide (CO), an odorless, colorless gas, which can cause sudden illness and death, is produced any time a fossil fuel is burned. CPSC recommends that one CO alarm be installed in the hallway outside the bedrooms in each separate sleeping area of the home. CO alarms may be installed into a plug-in receptacle or high on the wall. Hard wired or plug-in CO alarms should have battery backup. The Inspector strongly advises the home be equipped with carbon monoxide detectors.

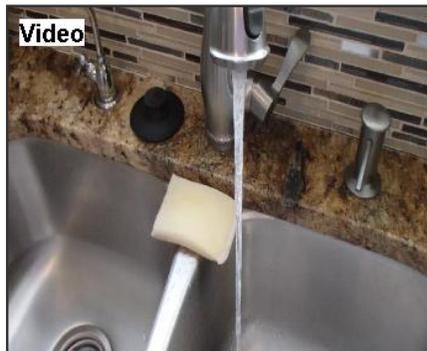
3.2. **SLUGGISH FLOW--KITCHEN FAUCET:** The kitchen water faucet has sluggish water flow. There may be debris in the valve. The Inspector advises the Client to arrange to have a professional, plumber further evaluate and address as necessary.

see video of water flow

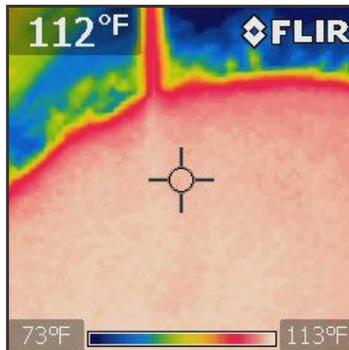
hot water temperature

- 6.1. Appears normal. The temperature should be maintained at 120° or less for safety and reduced wear and tear on the pipes.

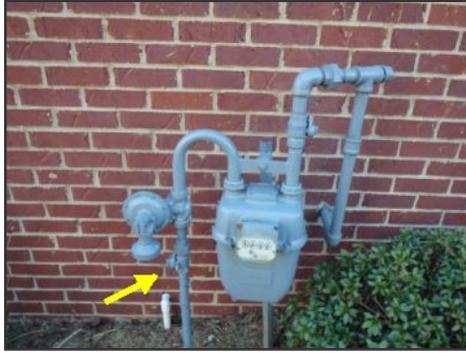
main gas valve

12.2. LEAK--MINOR--NATURAL GAS--NEAR METER: The Inspector observed a probable leak due to odor at the natural gas line at the meter. The leak should be investigated and repaired. Contact gas service provider.

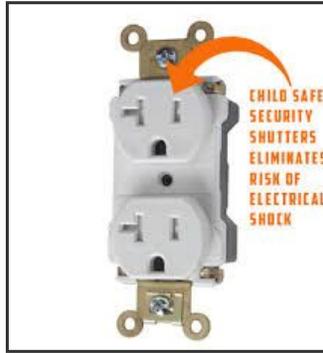
understanding tamper resistant receptacles

8.1. **Appears normal.** Normal conditions observed at sample-tested receptacles. Sample testing as per ASHI standard. Some receptacles may be obstructed (furnished homes).
 8.2. **TAMPER-RESISTANT RECEPTACLES:** The Client is advised to consider updating all of the home's receptacles to tamper-resistant type, new technology, for added electrical safety for children. Note that this technology is not a code requirement for older homes, but it is suggested as an upgrade for improved safety.

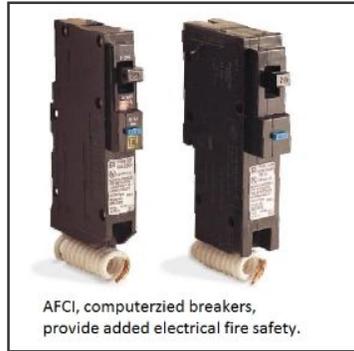
AFCI breakers

- 12.1. **AFCI** TECHNOLOGY: **AFCI** breakers, computerized breakers, are more effective than standard breakers at preventing electrical fires. It is advised to consider updating all of the home's 15 and 20 Amp single pole breakers to **AFCI** type, new technology, for added electrical fire safety. Note that this technology is not a code requirement for older homes, but it is suggested as an upgrade for improved safety.

AFCI, computerized breakers,
provide added electrical fire safety.

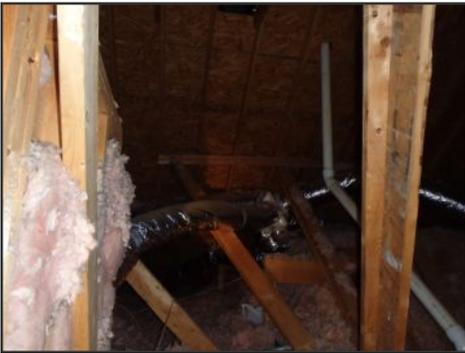
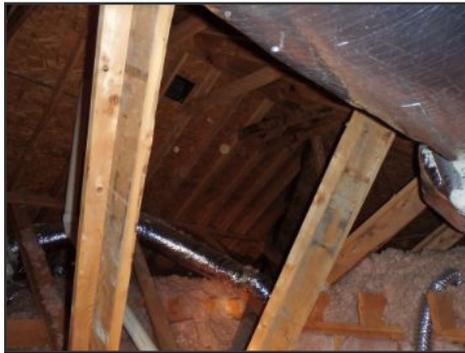
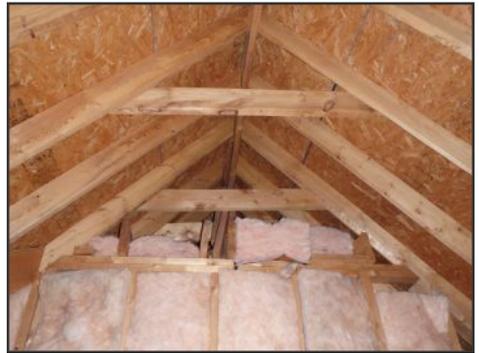
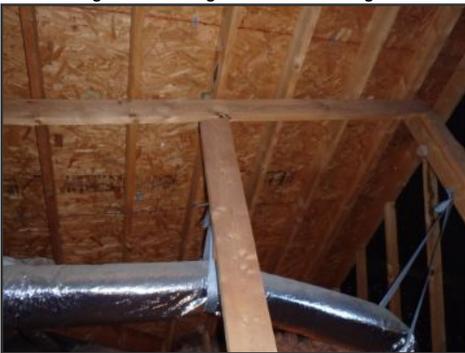
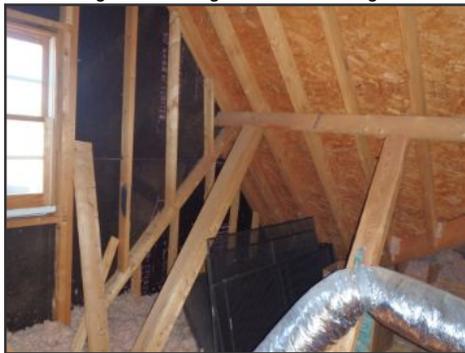
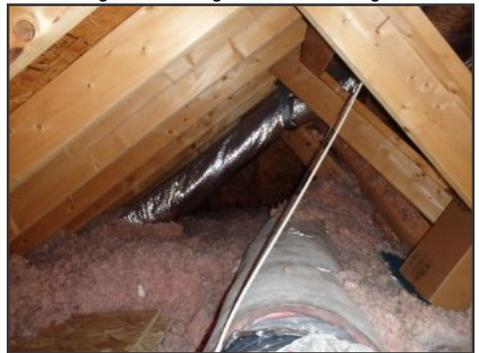
Roof Framing System: *Stick framing with 2x6 rafters.*
Ceiling joists: 2x8 dimensional lumber.
 Observations:
 4.1. Appears normal--ceiling joists. Note that insulation may conceal defects.
 4.2. Appears normal--rafters and supports.
