# Property Inspection REPORT

1234 Main Street, Decatur, GA 30030

INSPECTION PREPARED FOR: Atlanta Home Buyer

DATE OF INSPECTION: 8/21/2026

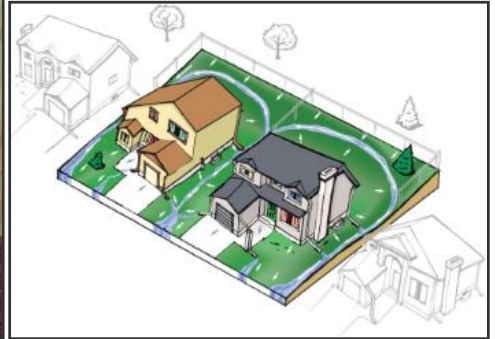
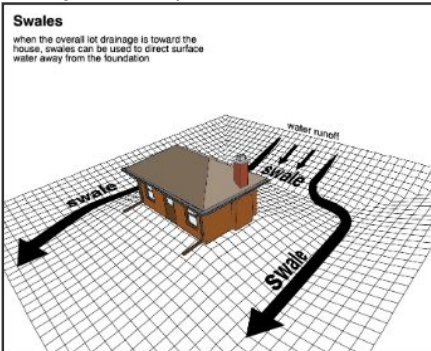
| Outdoor Environment | | |
|---|---|---|
| Page 10 Item: 1 | Exterior Grading | 1.2. REVERSE GRADING: Slight reverse grading was observed at the foundation wall at side B (left)--back side. The soil incorrectly slopes back towards the foundation. General construction practice requires a positive slope away from the foundation for adequate drainage. It is recommended that the slope be at least 6" drop for 10' horizontally (or as far as possible where lot lines are limiting). The Inspector advises the Client to arrange to have a professional landscape contractor further evaluate and address as necessary. (IRC: R401.3 Drainage. Lots shall be graded to drain surface water away from foundation walls. The grade shall fall a minimum of 6 inches within the first 10 feet.) |

1.2. **REVERSE GRADING:** Slight reverse grading was observed at the foundation wall at side B (left)--back side. The soil incorrectly slopes back towards the foundation. General construction practice requires a positive slope away from the foundation for adequate drainage. It is recommended that the slope be at least 6" drop for 10' horizontally (or as far as possible where lot lines are limiting). The Inspector advises the Client to arrange to have a professional landscape contractor further evaluate and address as necessary. (IRC: R401.3 Drainage. Lots shall be graded to drain surface water away from foundation walls. The grade shall fall a minimum of 6 inches within the first 10 feet.)

slight reverse pitch toward foundation

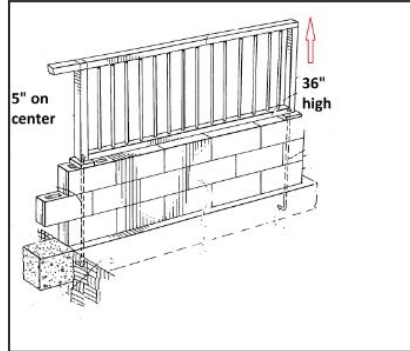
| Outdoor Environment | | |
|---|---|---|
| Page 10 Item: 2 | Driveway | 2.2. ELEVATED DRIVEWAY SECTION: The Inspector observed that the driveway is raised above grade along an approximately 12-foot linear portion at the right (Side D). In this section, the driveway surface is more than 30 inches above grade. This elevated condition presents a fall hazard. The Inspector advises the Client to arrange for a qualified contractor to install a protective guardrail or barrier at this section to reduce the risk of falls and improve safety (IRC R312 requires guards where walking surfaces are more than 30 inches above grade). |

2.2. **ELEVATED DRIVEWAY SECTION:** The Inspector observed that the driveway is raised above grade along an approximately 12-foot linear portion at the right (Side D). In this section, the driveway surface is more than 30 inches above grade. This elevated condition presents a fall hazard. The Inspector advises the Client to arrange for a qualified contractor to install a protective guardrail or barrier at this section to reduce the risk of falls and improve safety (IRC R312 requires guards where walking surfaces are more than 30 inches above grade).

portion of driveway is over 30" from grade

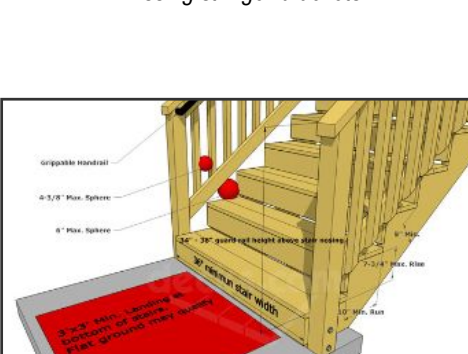
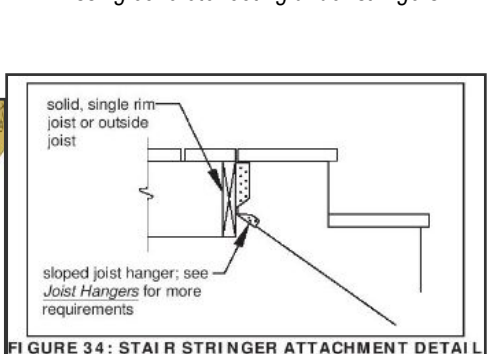
| Outdoor Environment | | |
|---|---|---|
| Page 12 Item: 5 | Deck Stairs | 5.2. DECK STAIR STRINGER SUPPORT – BOTTOM: The Inspector observed that the stair stringers are not resting sufficiently on top of the landing. A full bearing of the stringer foot should be in contact with the landing surface to prevent detachment and ensure proper load transfer. The Inspector advises the Client to arrange for a professional contractor to further evaluate and make repairs as necessary.<br>5.3. STAIR STRINGER BRACKETS--DECK STAIRS: The Inspector did not observe that the stair stringers are connected to the side of the deck with brackets. Current standards required sloped joist hanger brackets with 625 lb rating be installed to connect stringers and prevent detachment. The Inspector advises the Client to arrange to have a professional contractor further evaluate and address as necessary. |

5.2. DECK STAIR STRINGER SUPPORT – BOTTOM: The Inspector observed that the stair stringers are not resting sufficiently on top of the landing. A full bearing of the stringer foot should be in contact with the landing surface to prevent detachment and ensure proper load transfer. The Inspector advises the Client to arrange for a professional contractor to further evaluate and make repairs as necessary.

missing concrete footing under stringers

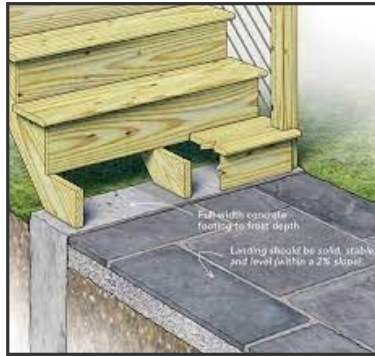
FIGURE 34: STAIR STRINGER ATTACHMENT DETAIL

5.3. STAIR STRINGER BRACKETS--DECK STAIRS: The Inspector did not observe that the stair stringers are connected to the side of the deck with brackets. Current standards required sloped joist hanger brackets with 625 lb rating be installed to connect stringers and prevent detachment. The Inspector advises the Client to arrange to have a professional contractor further evaluate and address as necessary.

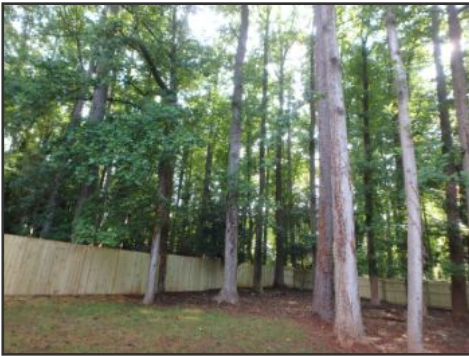
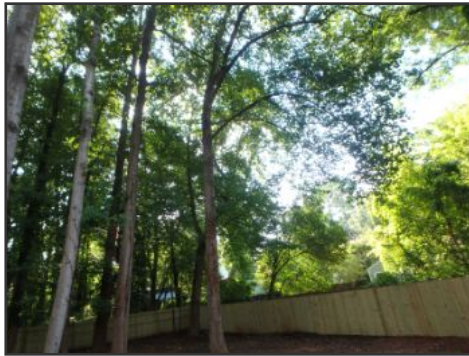
8.2. TREES--LARGE OLDER: The Inspector observed large trees at side C (rear) of the property that appeared to be live but older and possibly nearing the end of life. Consider having them evaluated by a certified arborist. They could cause damage to a structure or injure a person if they fall. The Inspector advises the Client to arrange to have an arborist further evaluate the trees for health and stability.

back yard trees

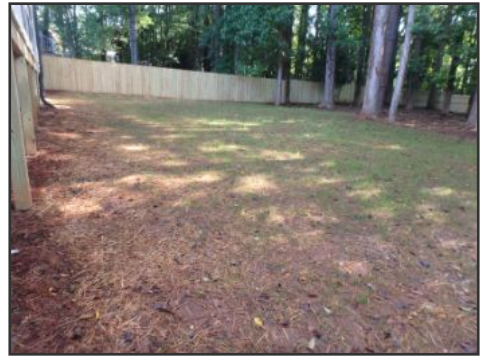
| Outdoor Environment | | |
|---|---|---|
| Page 13 Item: 8 | Vegetation | 8.3. LACKING GRASS/GROUND COVER: Areas of missing ground or poor ground cover (grass or mulch) were noted at side C (rear) of the property. The grass is thin and patchy. This may cause erosion problems. The Client is advised to have a professional landscaper further evaluate the grass and make corrections. |

8.3. LACKING GRASS/GROUND COVER: Areas of missing ground or poor ground cover (grass or mulch) were noted at side C (rear) of the property. The grass is thin and patchy. This may cause erosion problems. The Client is advised to have a professional landscaper further evaluate the grass and make corrections.

grass is thin

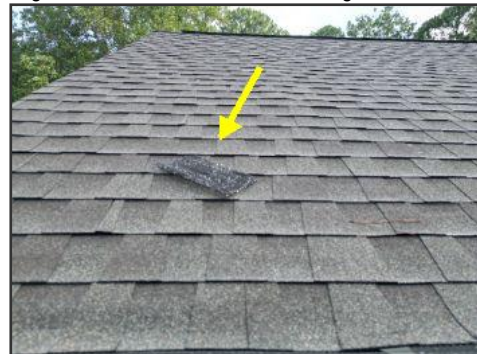
small piece of debris on roof covering

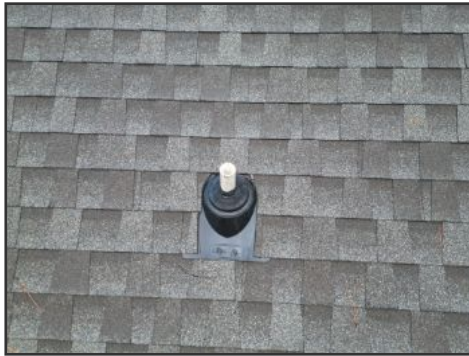
*example plumbing vent penetration*

4.1. Appeared normal. Vent seals at plumbing pipe penetrations sometimes crack with just a few years age. They should be monitored and replaced when they crack.

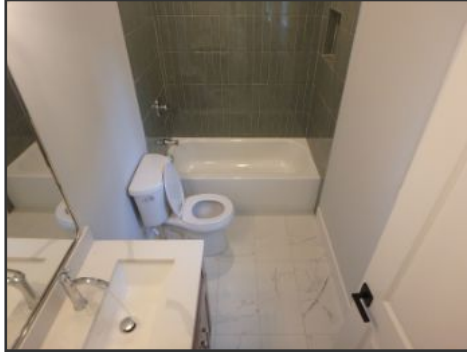
- 1.1. Appeared normal. Normal tub drain when tested for several minutes.
- 1.2. Appeared normal. Valve controls were tested.
- 1.3. GOOD NEWS: The shower head is low flow which should save water.
- 1.4. FILL SPOUT NECK--GAP--ENSUITE UPSTAIRS BATHROOM: The Inspector observed a gap at the tub fill spout where it intersects the shower wall. This could allow water to enter behind the wall. The Inspector advises the Client to arrange to have a professional contractor further evaluate and address as necessary.

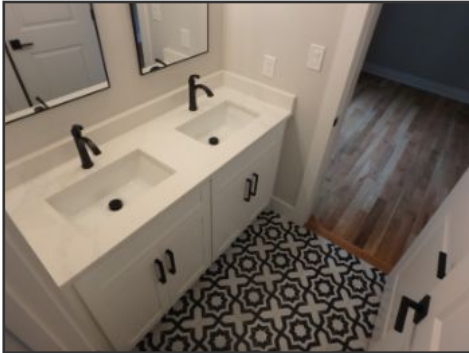
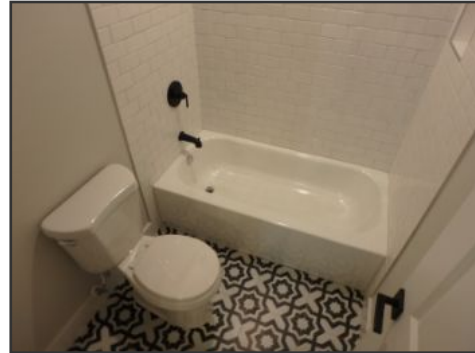
- 1.1. Appeared normal. Normal tub drain when tested for several minutes.  
 1.2. GOOD NEWS: The shower head is low flow which should save water.  
 1.3. TEMPERING VALVE—ADJUSTMENT NEEDED--JACK & JILL BATHROOM: The Inspector observed that the tub/shower control tempering valve needs adjustment for proper hot water flow. The Inspector advises the Client to arrange to have a professional, licensed plumbing contractor further evaluate and address as necessary.

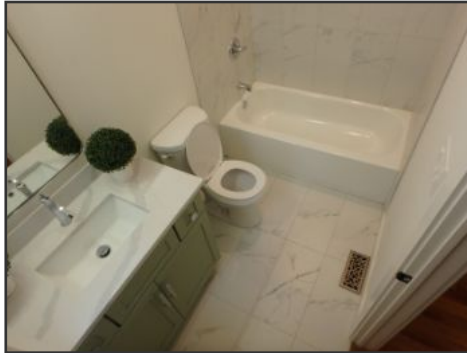
- 1.1. Appeared normal. Normal tub drain when tested for several minutes.  
 1.2. GOOD NEWS: The shower head is low flow which should save water.  
 1.3. TEMPERING VALVE—ADJUSTMENT NEEDED--MAIN FLOOR BATHROOM: The Inspector observed that the tub/shower control tempering valve needs adjustment for proper hot water flow. The Inspector advises the Client to arrange to have a professional, licensed plumbing contractor further evaluate and address as necessary.

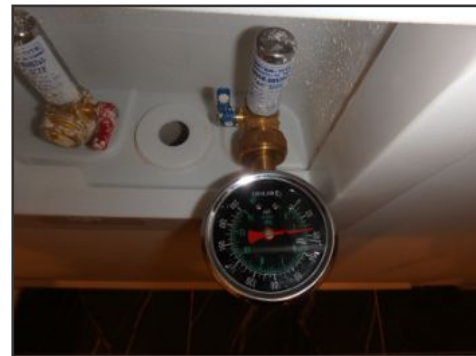
water pressure test

2.1. WATER PRESSURE TOO LOW: The Inspector tested with water pressure with a gauge and found it to be 36 psi. Adjustment or replacement of the water pressure control valve is recommended. Street pressure can also be tested by a plumber. The Inspector advises the Client to arrange to have a professional, licensed plumber further evaluate and address as necessary.

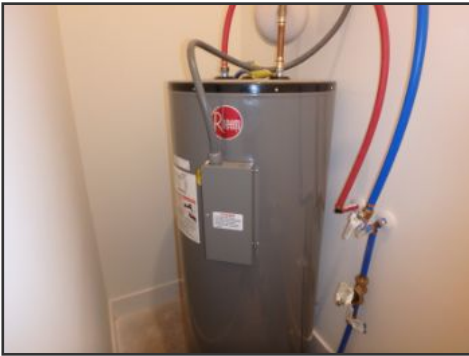
Rheem brand water heater

5.2. WATER HEATER-GENERAL CONDITION: The Inspector observed a Rheem Light-Duty commercial electric water heater, Model ELD80-TB (Serial # Q212540034), with an 80-gallon storage capacity. The unit is rated up to 12 kW and supports field-conversion between 208 V – 480 V, and single- or three-phase wiring, offering installation flexibility. It features a porcelain-enamel-lined tank, heavy-duty anode rod, thick polyurethane insulation, a surface-mounted thermostat with manual high-limit protection, and a durable brass drain valve. The unit is UL-certified, meets 150 psi working pressure standards, and includes a 3-year limited tank warranty and 1-year parts warranty. The Inspector recommends ensuring routine maintenance for continued safe and efficient operation.

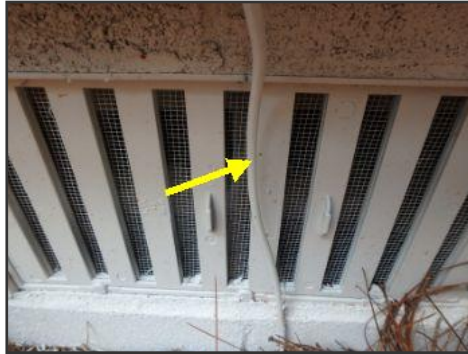
4.2. Grounding rod(s) in soil.

grounding conductor

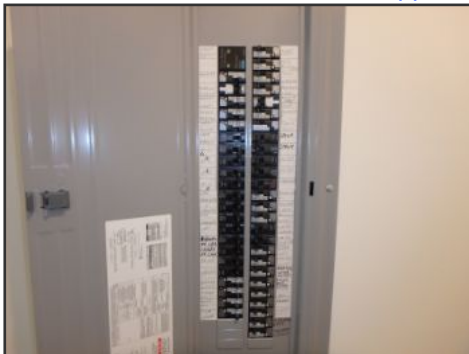
5.1. Appeared normal.

Siemens brand panelboard

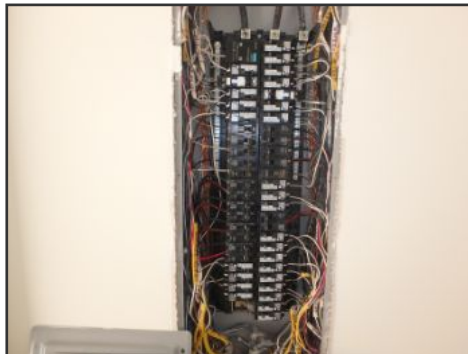
panelboard inside view

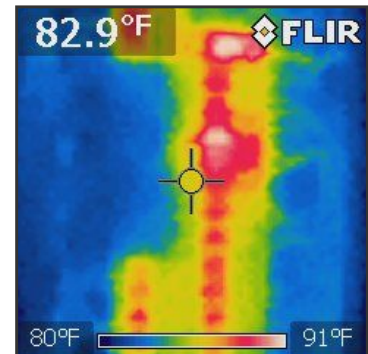
normal infrared image of panelboard

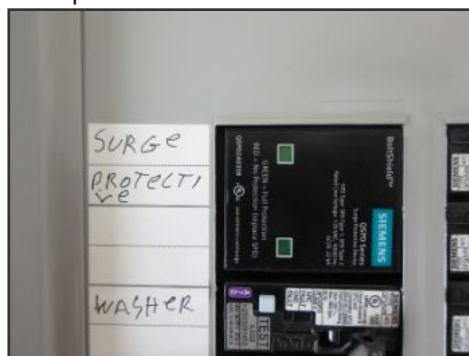
The home has a surge-protective device. This should mitigate possible damage to both the panelboard and to personal electronic devices should an electrical surge occur.

surge-protective device

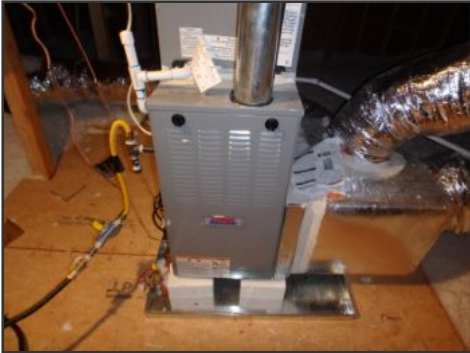
1.1. Appeared normal. Heating system was operated during the inspection.  
1.2. FURNACE--GENERAL CONDITION: The Inspector observed a Heil Performance Series, Model N80MSN0701716A single-stage gas furnace installed in a multi-position configuration. The unit features an efficient 18-speed ECM blower motor, induced-draft combustion fan, silicon nitride igniter, RPJ® heat exchanger, and an 80% AFUE rating. This configuration promotes quiet, reliable performance. The furnace is dual-fuel capable and includes safety features such as flame-rollout sensors and blocked-vent protection. The Inspector recommends regular maintenance in accordance with the manufacturer's specifications to ensure continued safe and efficient operation.

Heil brand furnace

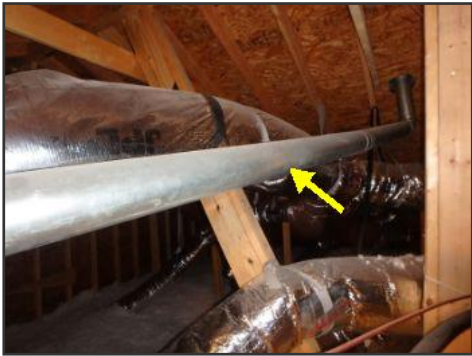
Observations:  
2.1. Appeared normal.

exhaust vent

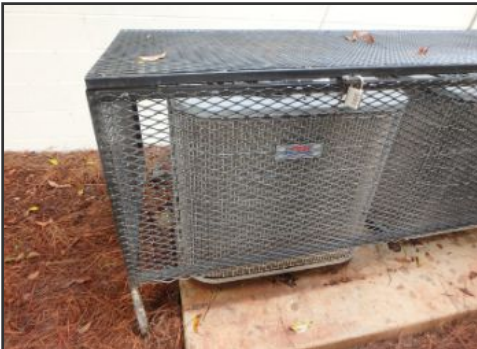
4.2. CONDENSER—GENERAL CONDITION: The Inspector observed an ICP/ACiQ Performance Series R5A5S36AKAWA 3-ton air conditioning condenser unit, featuring a 14.3 SEER2 efficiency rating and utilizing environmentally friendly R-454B refrigerant. The unit includes a durable cabinet design, scroll compressor, internal pressure relief and thermal overload protection, and is pre-charged for a 15-ft line set to streamline installation. The unit is backed by a 10-year parts warranty when properly registered. The Inspector recommends ensuring system registration to maintain warranty coverage and optimize energy performance.

Heil brand outdoor unit

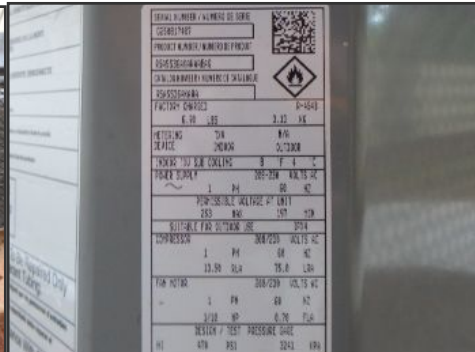
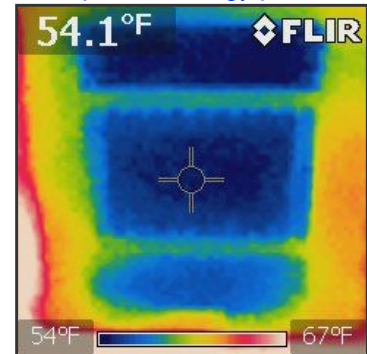
normal temperature drop

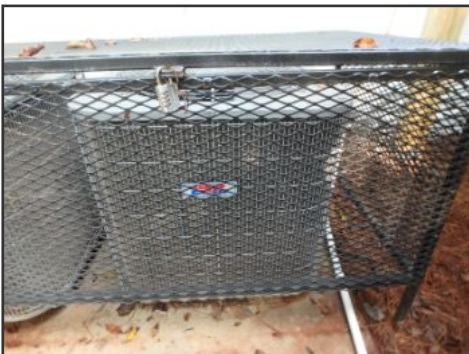
4.2. CONDENSER – GENERAL CONDITION: The Inspector observed an ICP / ACiQ R5A5S36AKAWA 3-ton, single-stage condenser unit. The system is rated at 14.3 SEER2 and utilizes R-454B refrigerant, meeting modern environmental efficiency standards. Key features include a scroll compressor, internal pressure relief and thermal overload protection, a field-installable filter drier, and a robust cabinet with reinforced corners and coil protection. The unit comes factory-pre-charged for a 15-ft line-set and is designed for considerable line-length flexibility. The manufacturer provides a 10-year parts warranty when registered properly. The Inspector recommends timely registration to ensure efficient, reliable operation and maintain warranty coverage.

Heil brand outdoor unit

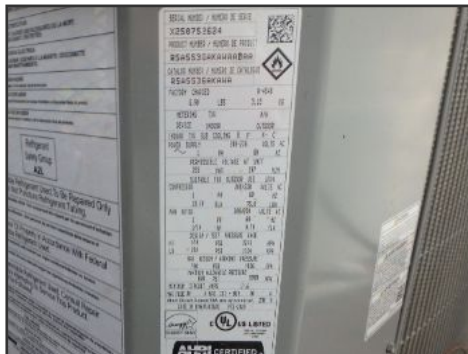
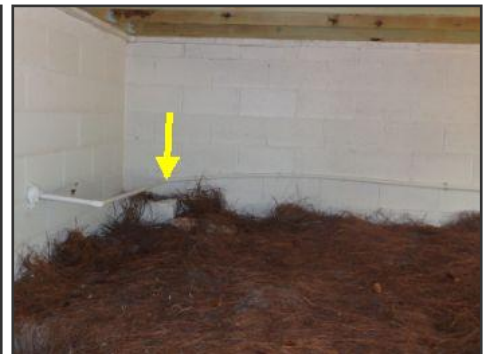
4.3. CONDENSATE DRAIN--MAIN: The Inspector observed a "valley" and deficient slope in the condensate drain pipe serving the air conditioning system, prior to its termination at the exterior. Improper slope can allow water to collect in the line, leading to restricted drainage, microbial growth, or system shutdown. The Inspector advises the Client to have a qualified HVAC contractor correct the drain line to provide a continuous, code-compliant slope to the exterior termination.

"valley" at condensation drain pipe

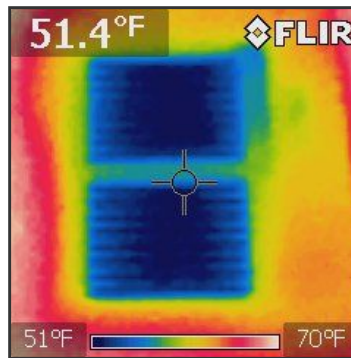
*normal temperature drop*

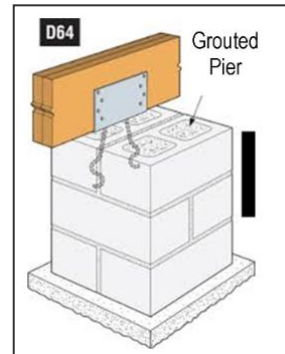
5.2. CRAWL SPACE-IMPROPER SUPPORT: The Inspector observed a two-ply 2x6 support post located at the front of the home, approximately under the foyer, supporting the girder tail. The post is resting on stacked blocks of scrap wood directly on the soil. This is not a proper load-bearing installation and does not provide a stable or permanent foundation. Posts of this type should be supported by a properly sized, poured-in-place concrete footing to distribute loads adequately and prevent settlement. The Inspector advises the Client to have a qualified contractor install a code-compliant footing and properly reset the support post.

deficient girder support
