# Property Inspection REPORT

1000 Any Street, Atlanta, GA 30301

DATE OF INSPECTION: 5/13/2026

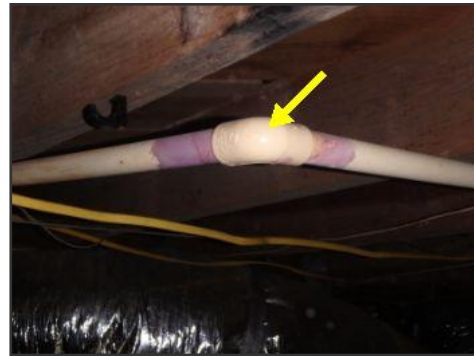
sagging pipe example

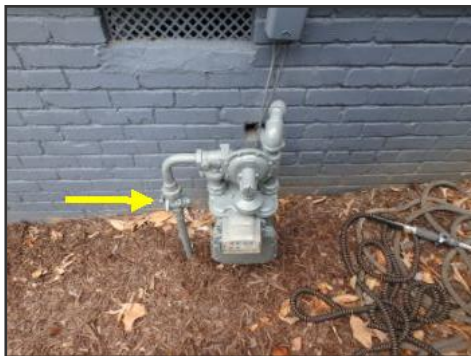
10.2. MAIN GAS VALVE: The home has a main gas valve on the utility provider's side of the meter; however, there is no main gas valve on the homeowner's side of the gas meter. This is very common for older homes. Newly adopted fuel gas standards require two main gas shutoff valves. Sometimes gas supply companies require the secondary valve to be installed during a change of ownership or lapse in service. This is not always required. The Inspector advises that the Client arrange to have a professional licensed plumbing contractor further evaluate and address as necessary.

main gas fuel valve--side A

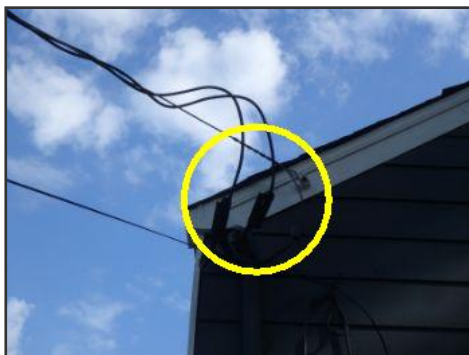
*service drop connections*

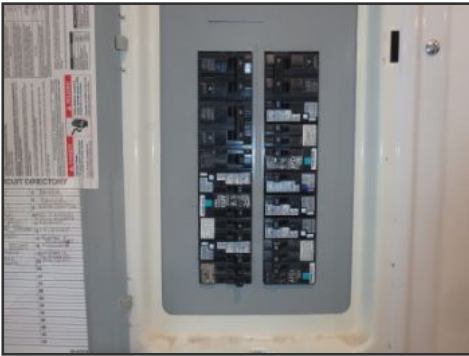
5.2. ELECTRICAL PANEL – BREAKER / CIRCUIT LABELING: An older ITE tandem breaker assembly was observed at the electrical panel. While functional at the time of inspection, this older breaker configuration is aged and updating is recommended as part of ongoing electrical maintenance. In addition, the circuit directory was noted to be inaccurate. For example, the directory identifies the dryer circuit at the top-right breaker position, which does not match the observed panel configuration. Recommend evaluation by a qualified electrical contractor to verify breaker compatibility, replace outdated components as needed, and accurately identify and relabel all branch circuits.

Siemens brand panelboard

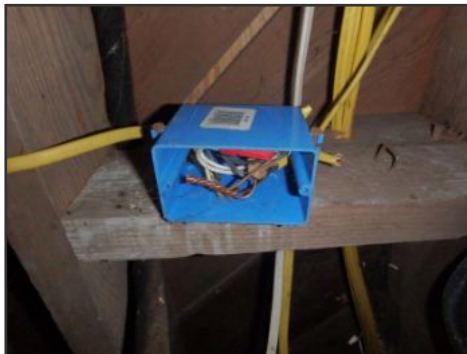
7.4. **OPEN JUNCTION BOX—CRAWL SPACE:** The Inspector observed one open electrical junction box in the crawl space beneath the home. Junction boxes should be properly enclosed with an approved cover plate to protect wiring connections from accidental contact, physical damage, and other electrical safety concerns. This is generally a minor condition that can be readily corrected. The Inspector advises the Client to arrange to have a professional, licensed electrician further evaluate and address as necessary.

open junction box

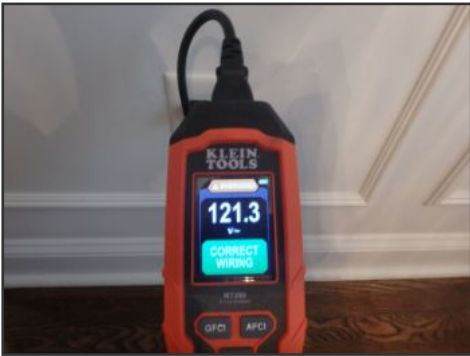
example receptacle testing

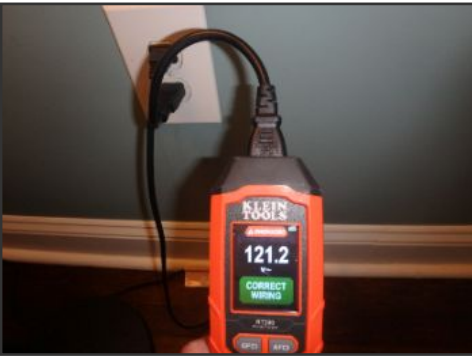
example receptacle testing

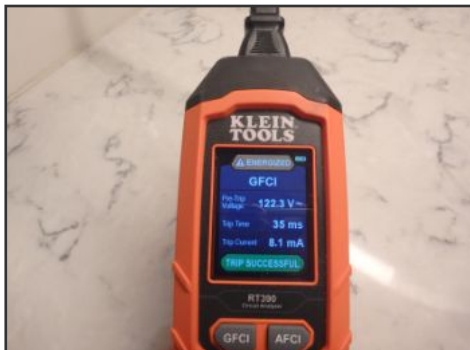
example GFCI testing

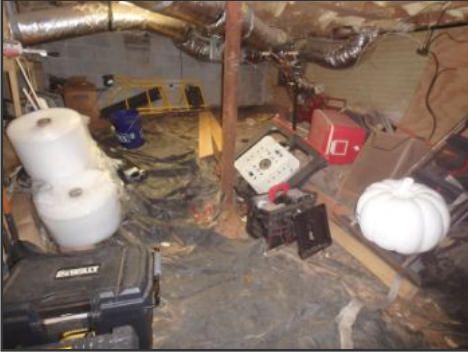
general image of crawl space

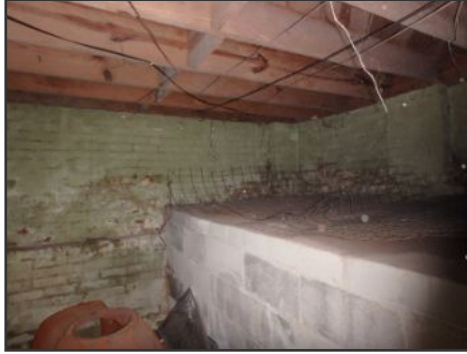
general image of crawl space

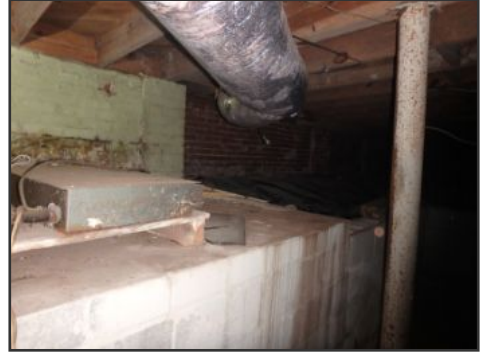
general image of crawl space

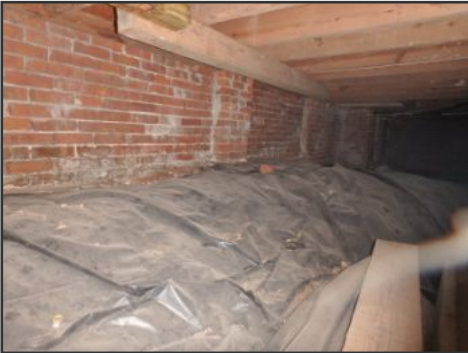
general image of crawl space

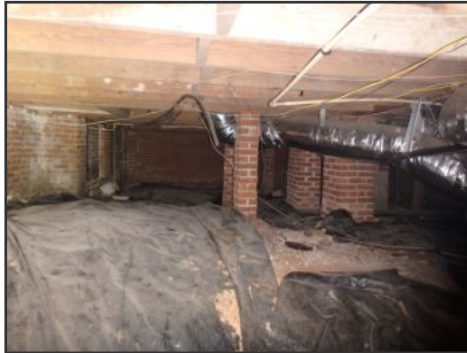
general image of crawl space

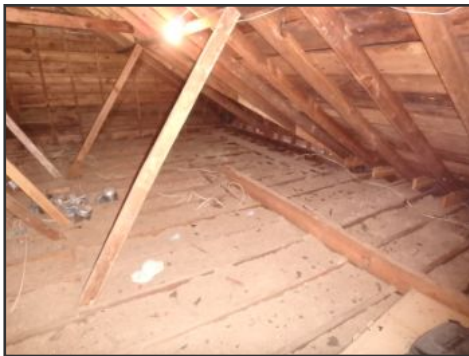
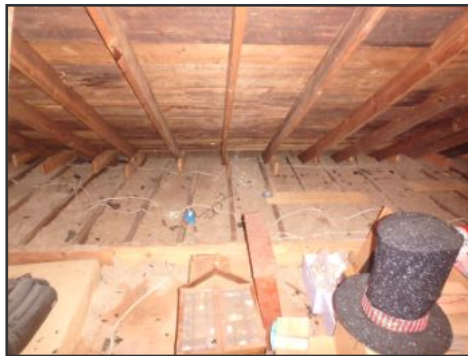
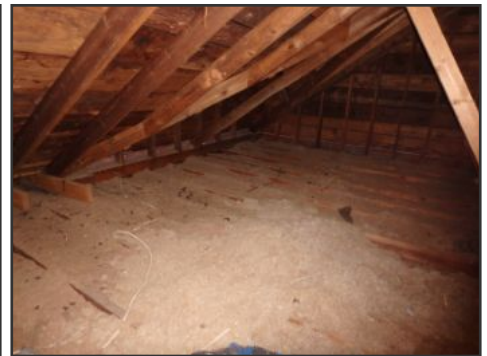
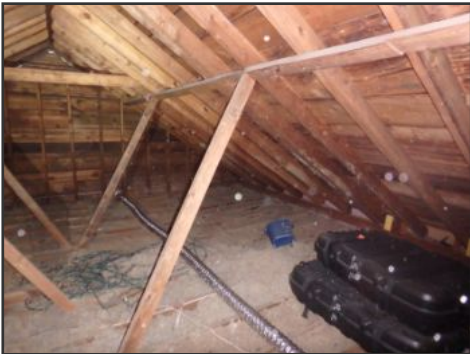
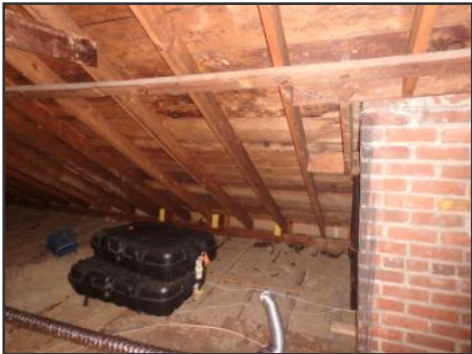
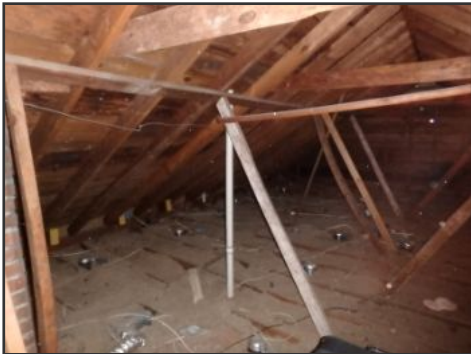
- 4.1. ATTIC ROOF FRAMING: The attic roof framing consists of nominal 2x6 rafters and 2x6 ceiling joists. Concerns were noted regarding the existing roof support framing configuration, including single 2x4 purlins with support struts spaced approximately 6 to 8 feet apart and collar ties spaced approximately 10 feet apart. This framing appears lighter and less robust than typically recommended for improved structural support. Recommend further evaluation and upgrading by a qualified general contractor. Improvements should include installation of properly sized purlins (typically minimum 2x4 installed on edge), support struts installed at closer intervals (commonly not exceeding approximately 4 feet on center) with solid bearing to suitable framing below, and additional collar ties installed at more regular intervals (commonly every 4 feet on center or as appropriate for the framing configuration) to improve roof stability and load distribution.

general image of attic / roof framing

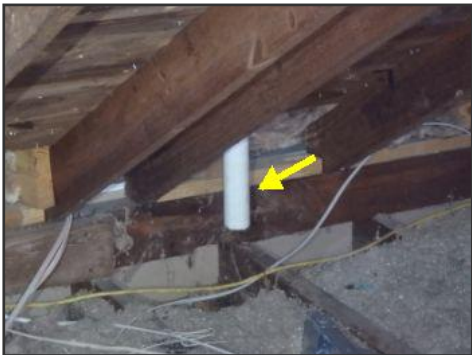
5.2. ABANDONED/UNUSED ROOF PENETRATION: An apparent unused PVC pipe penetration was observed extending through the roof structure, reportedly at the rear (Side C) portion of the home. This appears to be an abandoned or unused plumbing vent penetration. Unused roof penetrations can present potential pathways for moisture intrusion, pest entry, and air leakage if not properly terminated and sealed. Recommend evaluation and proper correction by a qualified contractor, which may include permanent removal and proper roof patching or approved sealed termination as appropriate.

unused PVC vent pipe
