# Property Inspection REPORT

1000 Any Street, Atlanta, GA 30301

DATE OF INSPECTION: 5/13/2026

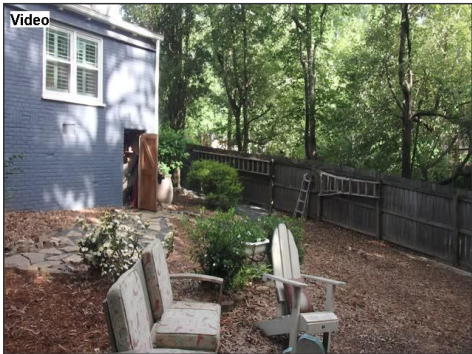
8.4. INSPECTOR TIP--STAINING/PAINTING--FENCE: The Inspector observed a preservatively-treated pine fence. While the fence appeared to be treated, painting or staining the fence will further extend the serviceable lifespan of the structure. The Inspector advises the Client to arrange to have a professional contractor further evaluate and address as necessary. Or, do it yourself with advice from your paint supply store.

VIDEO--fence span

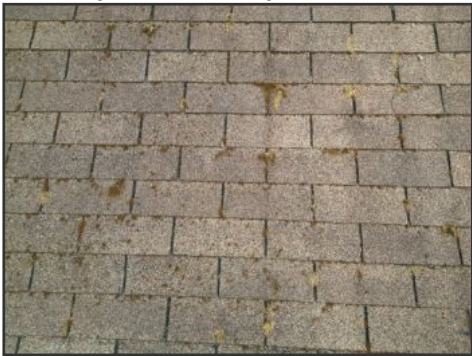
**1.1. MAIN ROOF COVERING:** The roof is reportedly approximately 15 years old and consists primarily of standard-grade asphalt three-tab shingles, with rolled roofing material installed at the front porch and rear low-slope roof sections. Visible roof coverings showed typical age-related wear including moderate granular loss, isolated biological growth/debris accumulation, and weathering consistent with mid-to-late service life. The rolled roofing sections exhibited more advanced surface weathering/crazing consistent with aging and ongoing exposure. No active leakage was confirmed at the time of inspection; however, due to observed wear and the age of the materials, continued monitoring, routine maintenance, and budgeting for future roof covering replacement should be anticipated. Insurance policy inspectors may have a different assessment of the roof covering and may deny a policy.

example close-up

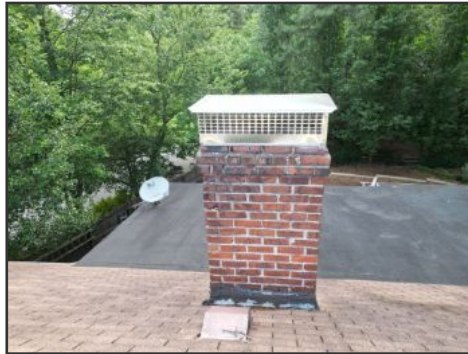
4.1. **MASONRY CHIMNEY:** The exterior masonry chimney appeared generally serviceable at the time of inspection. Visible masonry components appeared intact; however, areas of sealant/patching were noted at the base flashing intersection consistent with wear. Continued monitoring and routine maintenance of chimney flashing and masonry sealant joints is recommended to help reduce the potential for moisture intrusion.

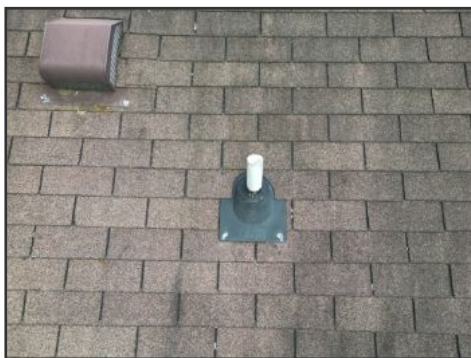
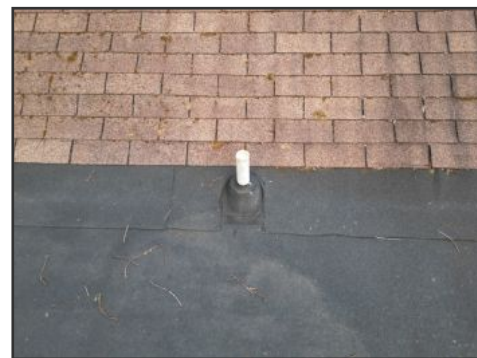
6.1. **PLUMBING VENT PIPE PENETRATIONS:** Multiple plumbing vent pipe roof penetrations were observed. Visible vent flashing boots appeared generally intact at the time of inspection with no obvious active leakage indicators visible from the roof surface. Sealants at some flashing terminations appear aged and weathered, and these roof penetrations should be considered routine maintenance points due to their higher likelihood of leakage over time. Continued monitoring and periodic resealing or replacement of flashing components as needed is recommended as part of normal roof maintenance.

example vent penetration

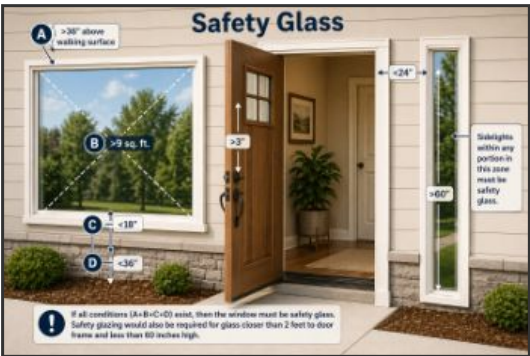
| Interior | | |
|---|---|---|
| Page 21 Item: 5 | Safety Glazing (Tempered Glass) | 5.2. WINDOW GLAZING – SAFETY CONCERN: Windows immediately adjacent to the exterior door at the Side D sunroom appear to contain non-tempered glazing despite being located within the hazardous location zone near the door. Modern safety standards require tempered safety glass in this location to reduce the risk of injury from accidental human impact and glass breakage. Recommend replacement with approved tempered safety glazing by a qualified contractor for improved occupant safety. |

windows should have tempered glazing

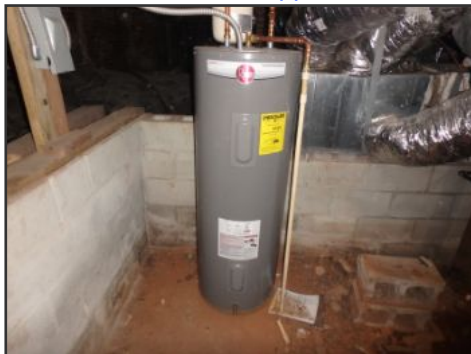
5.1. Appeared normal. Appliance operated at time of inspection.

Rheem brand water heater

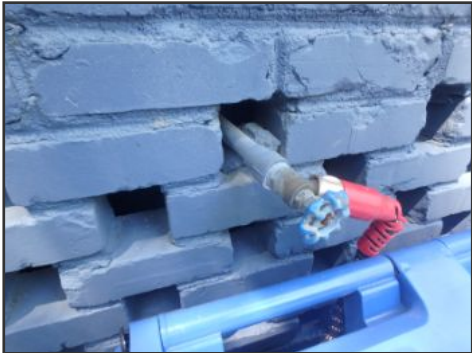
Observations:  
8.1. Appeared normal at side A.  
NOTE: It is very important to shut off and drain hose faucets in the winter to prevent freezing. Frozen pipes can rupture and leak causing damage to homes.  
8.2. HOSE BIB SUPPLY PIPE – FREEZE RISK: The water supply pipe serving the exterior hose faucet at Side C is routed through an open brick cavity where it is exposed to outside air. This installation can allow cold winter temperatures to reach the piping, increasing the risk of freezing, pipe rupture, and resulting water damage. Recommend correction by a qualified plumbing contractor to better protect this piping from freeze exposure.

hose bib

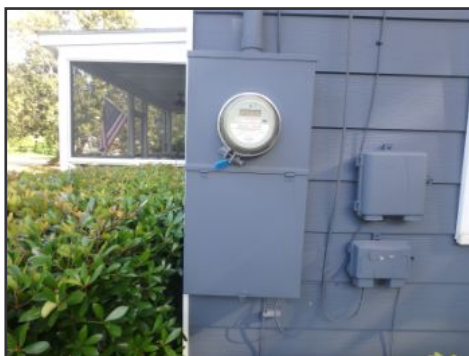
*meter base*

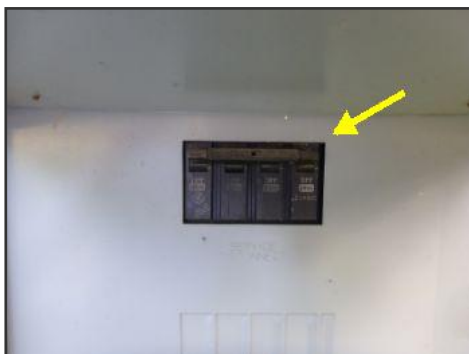
*main disconnect*

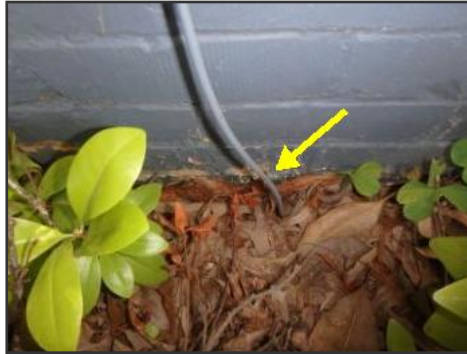
4.1. Appeared normal. However, note that continuity from the panelboard to the electrode is not verified as part of the inspection.

4.2. Grounding rod(s) in soil.

grounding

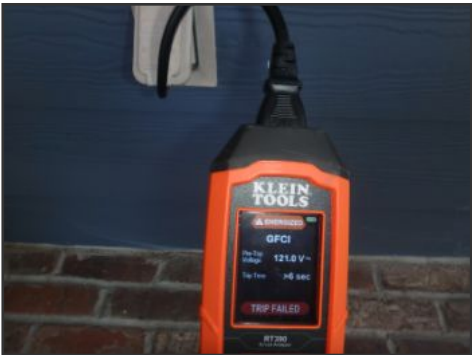
example AFCI testing

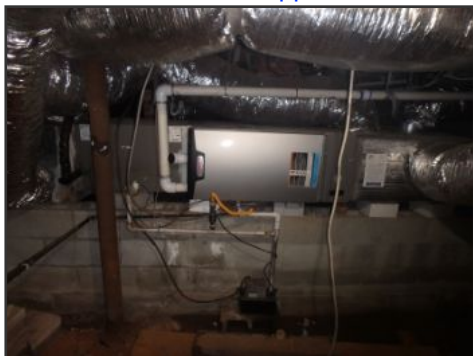
furnace

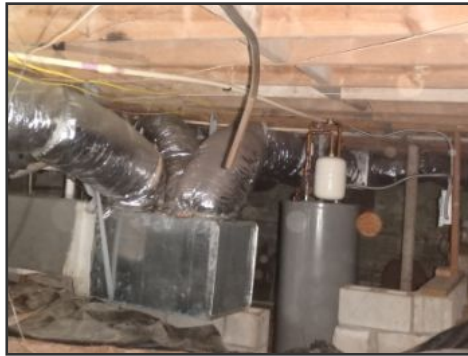
example ductwork

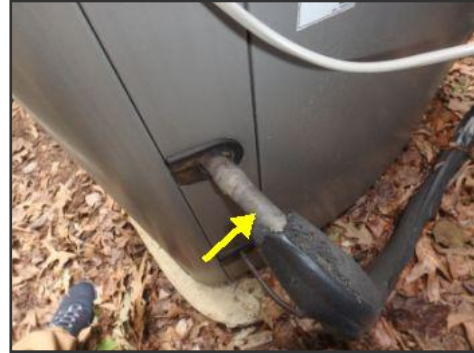
5.2. HVAC REFRIGERANT LINE INSULATION—DAMAGED / INCOMPLETE: The exterior refrigerant suction line insulation serving the HVAC system is damaged, deteriorated, and incomplete in areas, leaving portions of the refrigerant line exposed. Missing or compromised insulation can reduce system efficiency, contribute to unnecessary energy loss, and may promote condensation-related deterioration over time. The Inspector recommends replacement of the damaged insulation to fully protect the exposed refrigerant line.

insulation gap

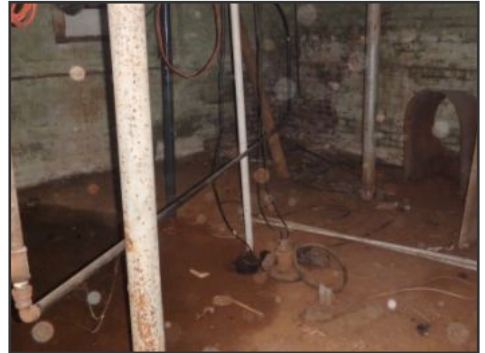
general image of cellar

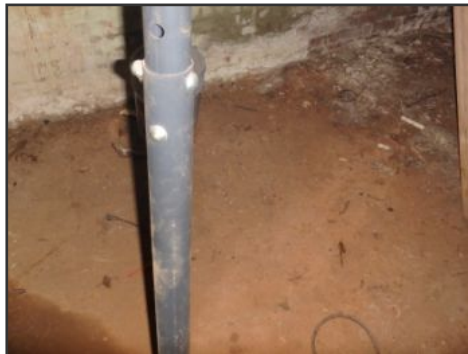
example jack post
